**6 Grand Avenue, Rosehill NSW**

**Hale Capital Development Management Pty Ltd**

**Remedial Action Plan**

**1 November 2024**

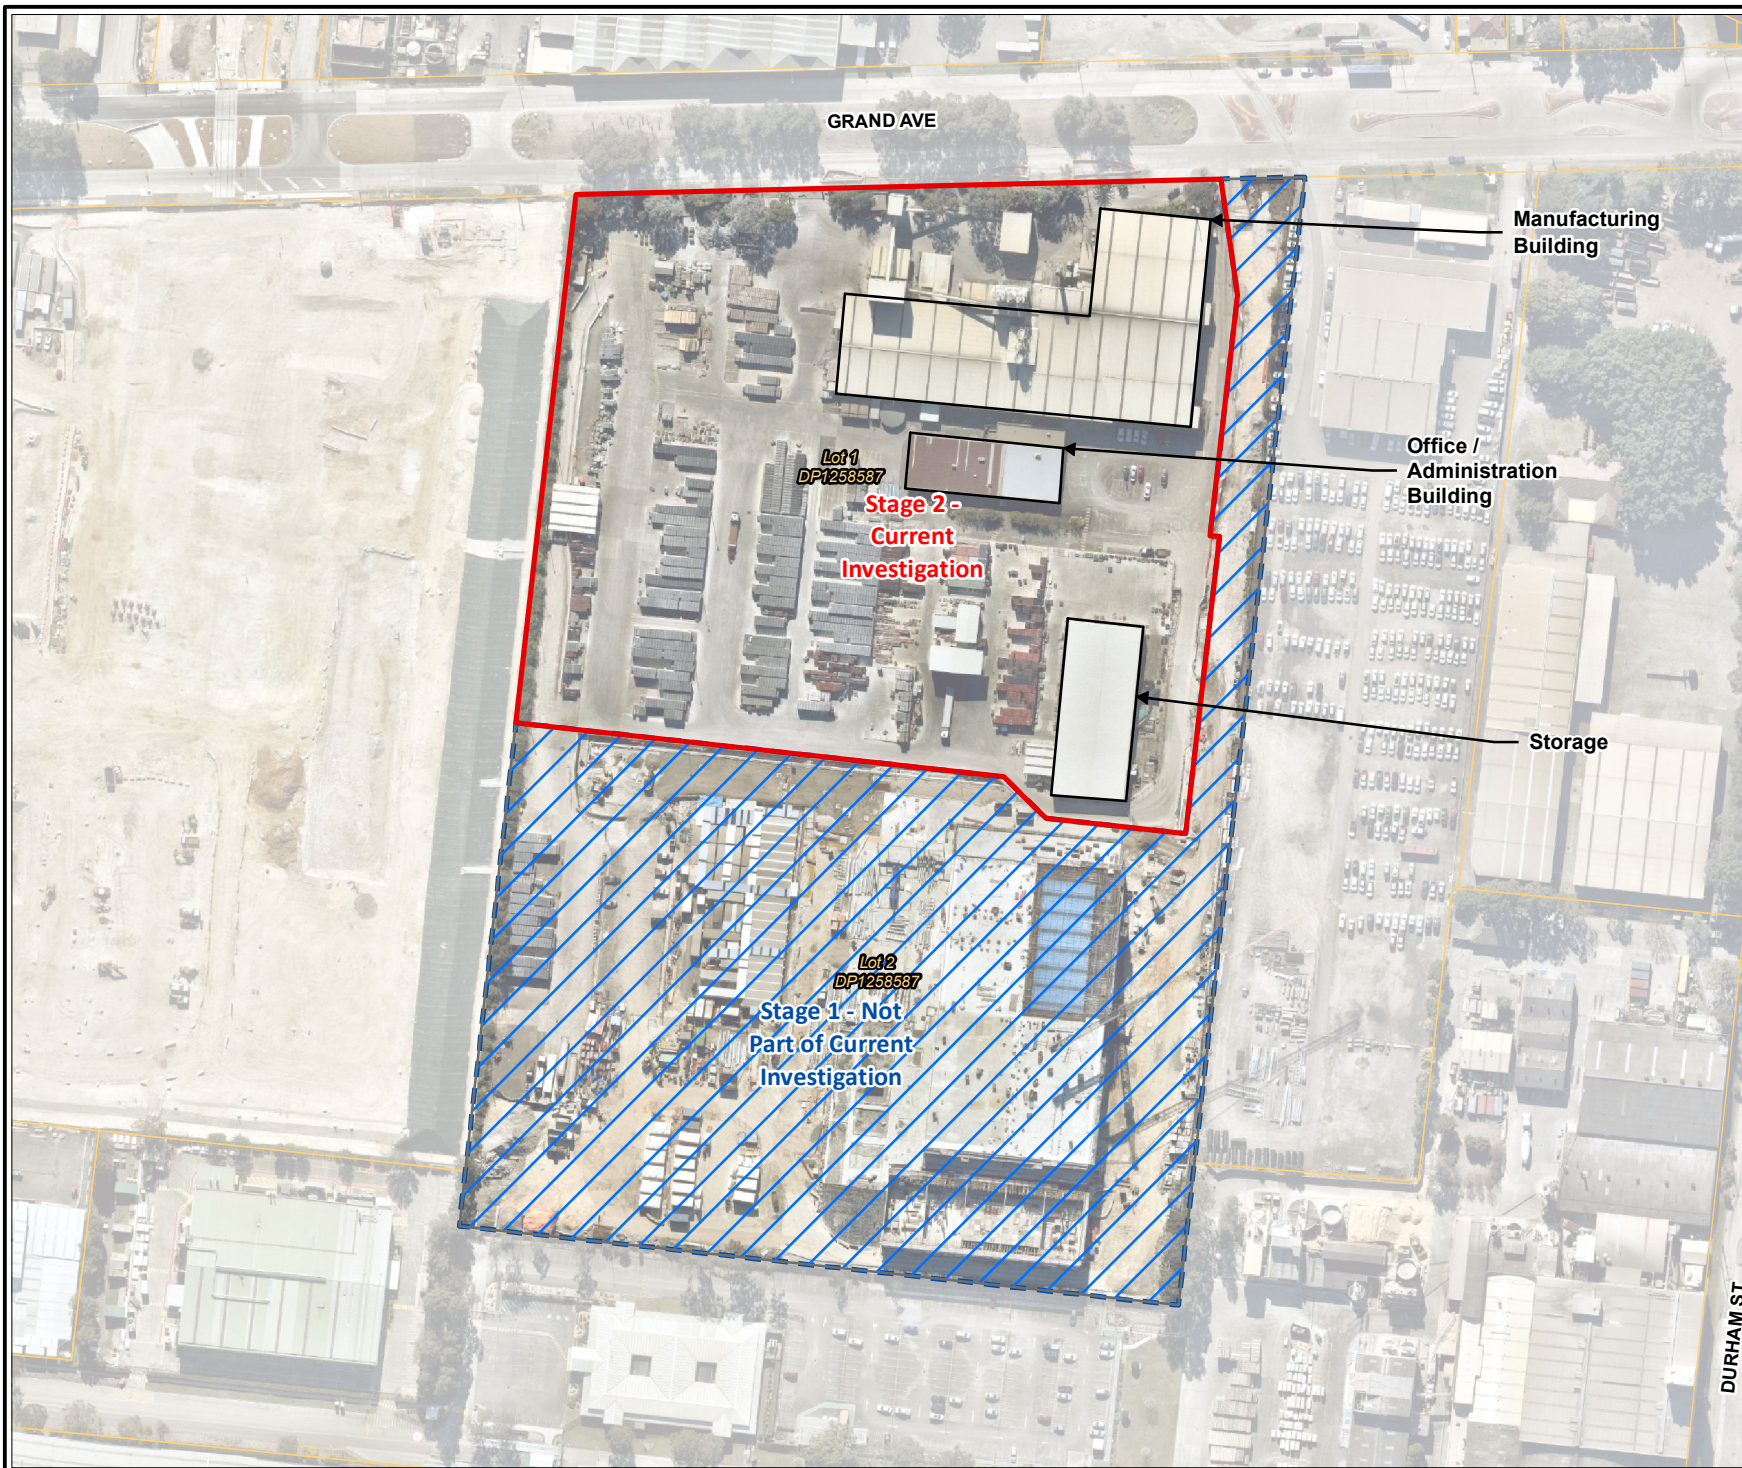
**FIGURE 2**

**SITE LAYOUT**

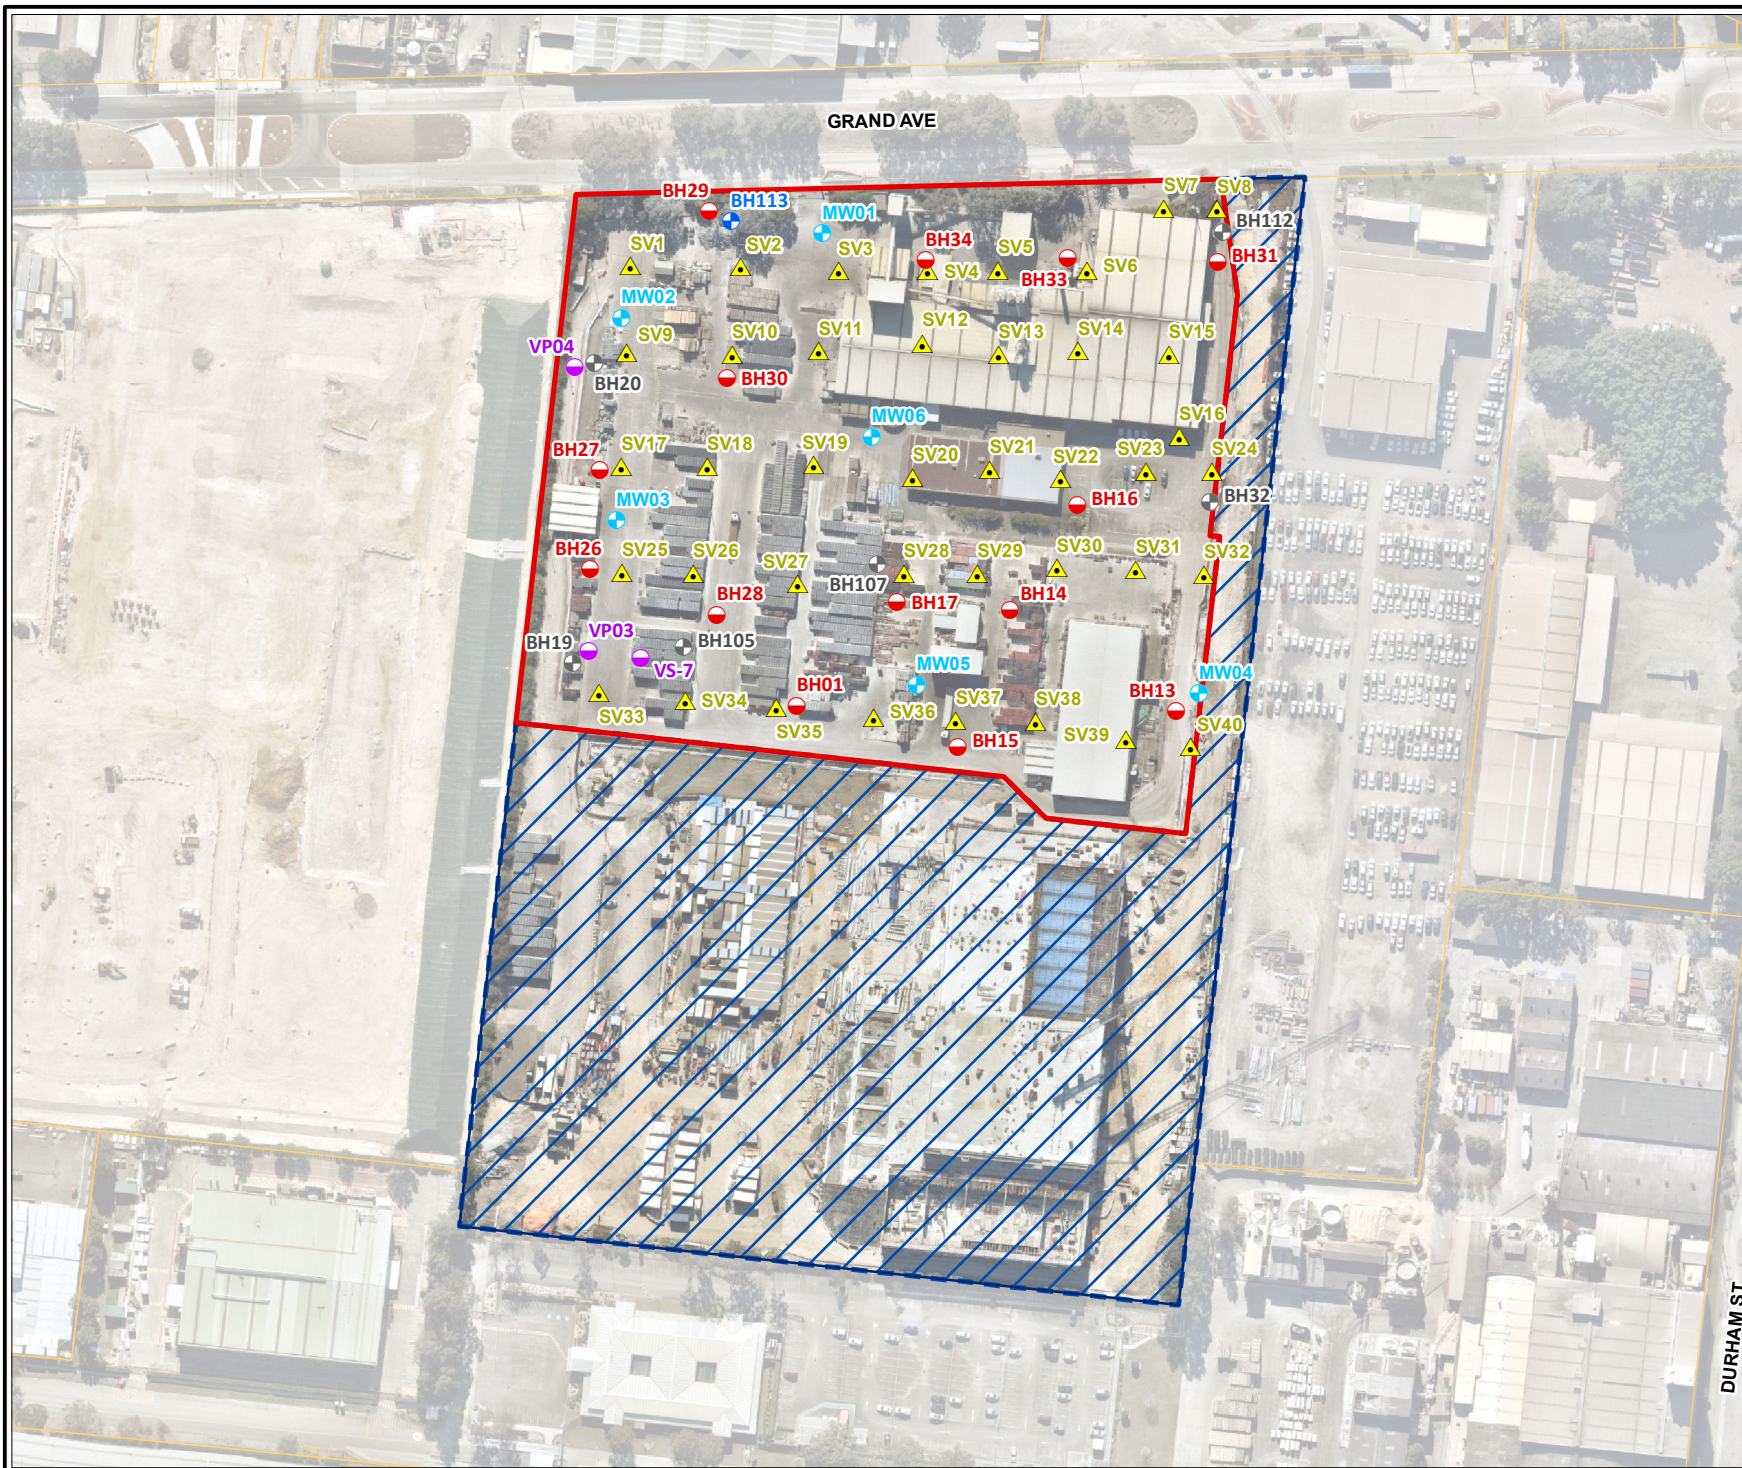
**FIGURE 3**

**CURRENT INVESTIGATION AND  
HISTORICAL SAMPLE LOCATIONS**
