# Site Audit Statement

Site audit statement no. RS-117A

Address: 6 Grand Avenue, Rosehill NSW (previously identified as 10 Grand Avenue, Camellia)

'Long-Term Environmental Management Plan, 6 Grand Avenue, Rosehill NSW', 18 August 2026, EGA

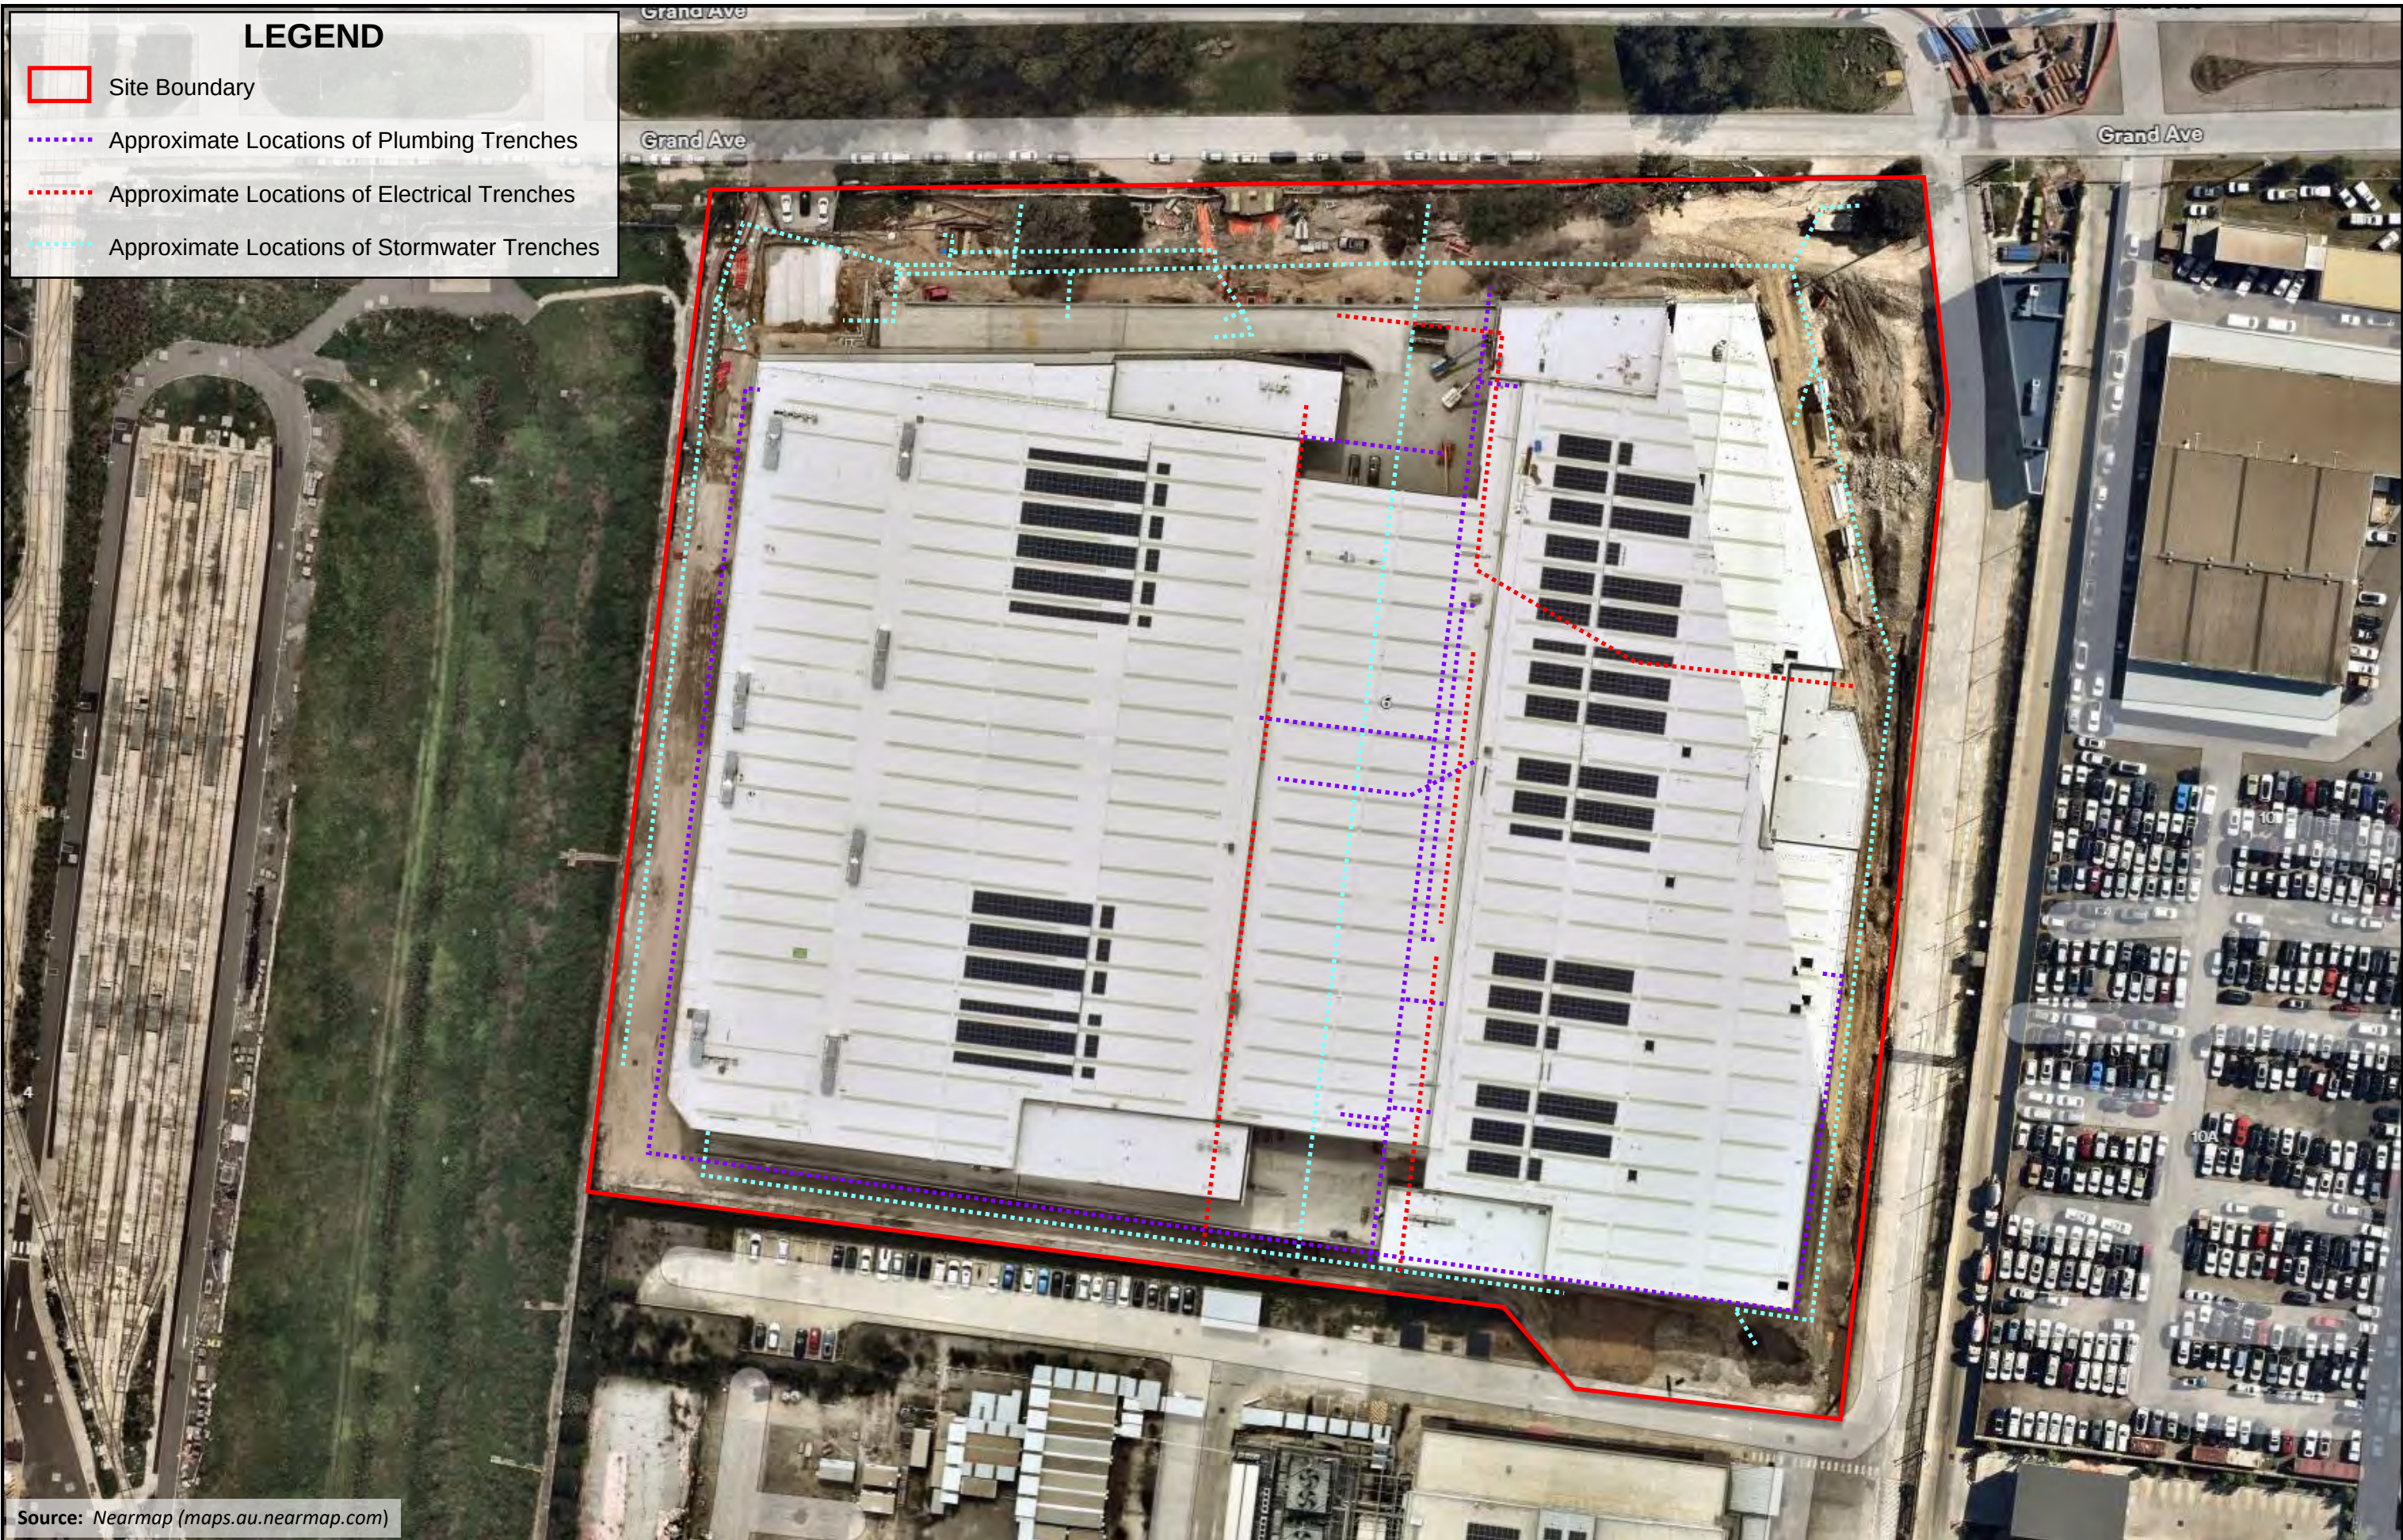
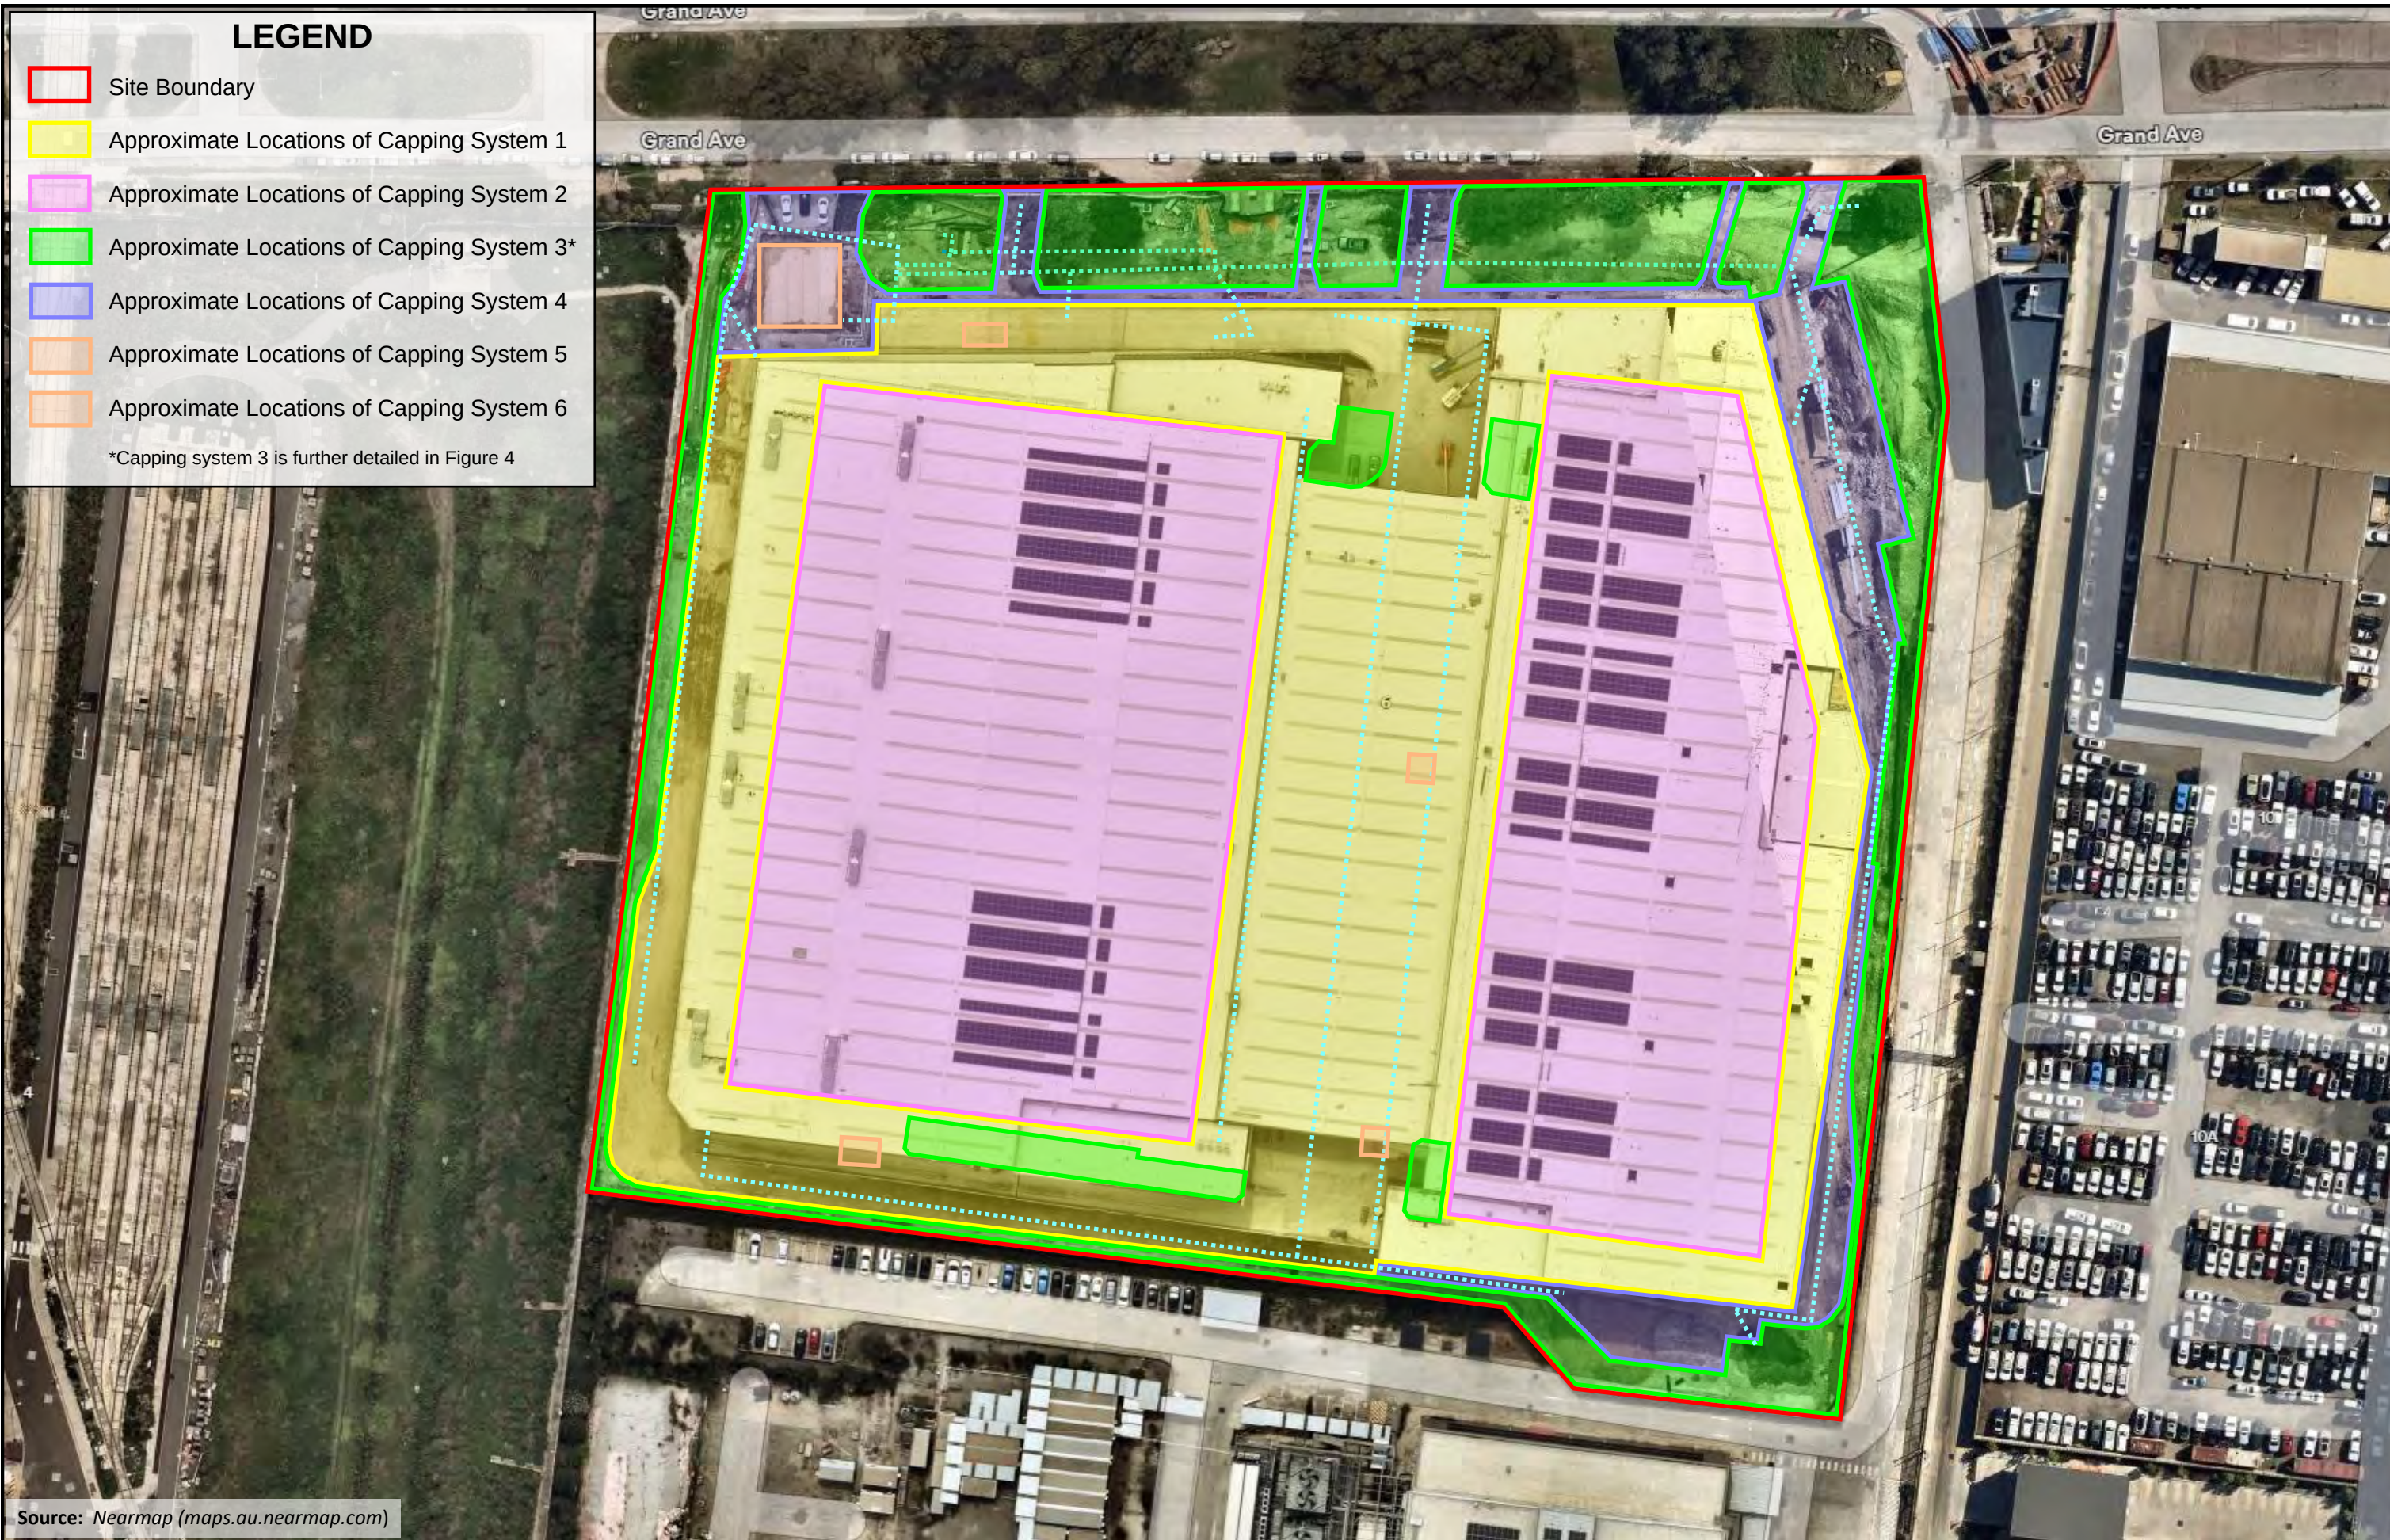
This LTEMP describes conditions of the site and details management strategies of the contained impacted soils. The protocols outlined in this LTEMP must be considered in future works that may result in a breach of the capping layer covering the impacted soils on-site (refer to **Figures 3 & 4** and **Appendix A**).

- Site Boundary
- Approximate Locations of Capping System 1
- Approximate Locations of Capping System 2
- Approximate Locations of Capping System 3\*
- Approximate Locations of Capping System 4
- Approximate Locations of Capping System 5
- Approximate Locations of Capping System 6

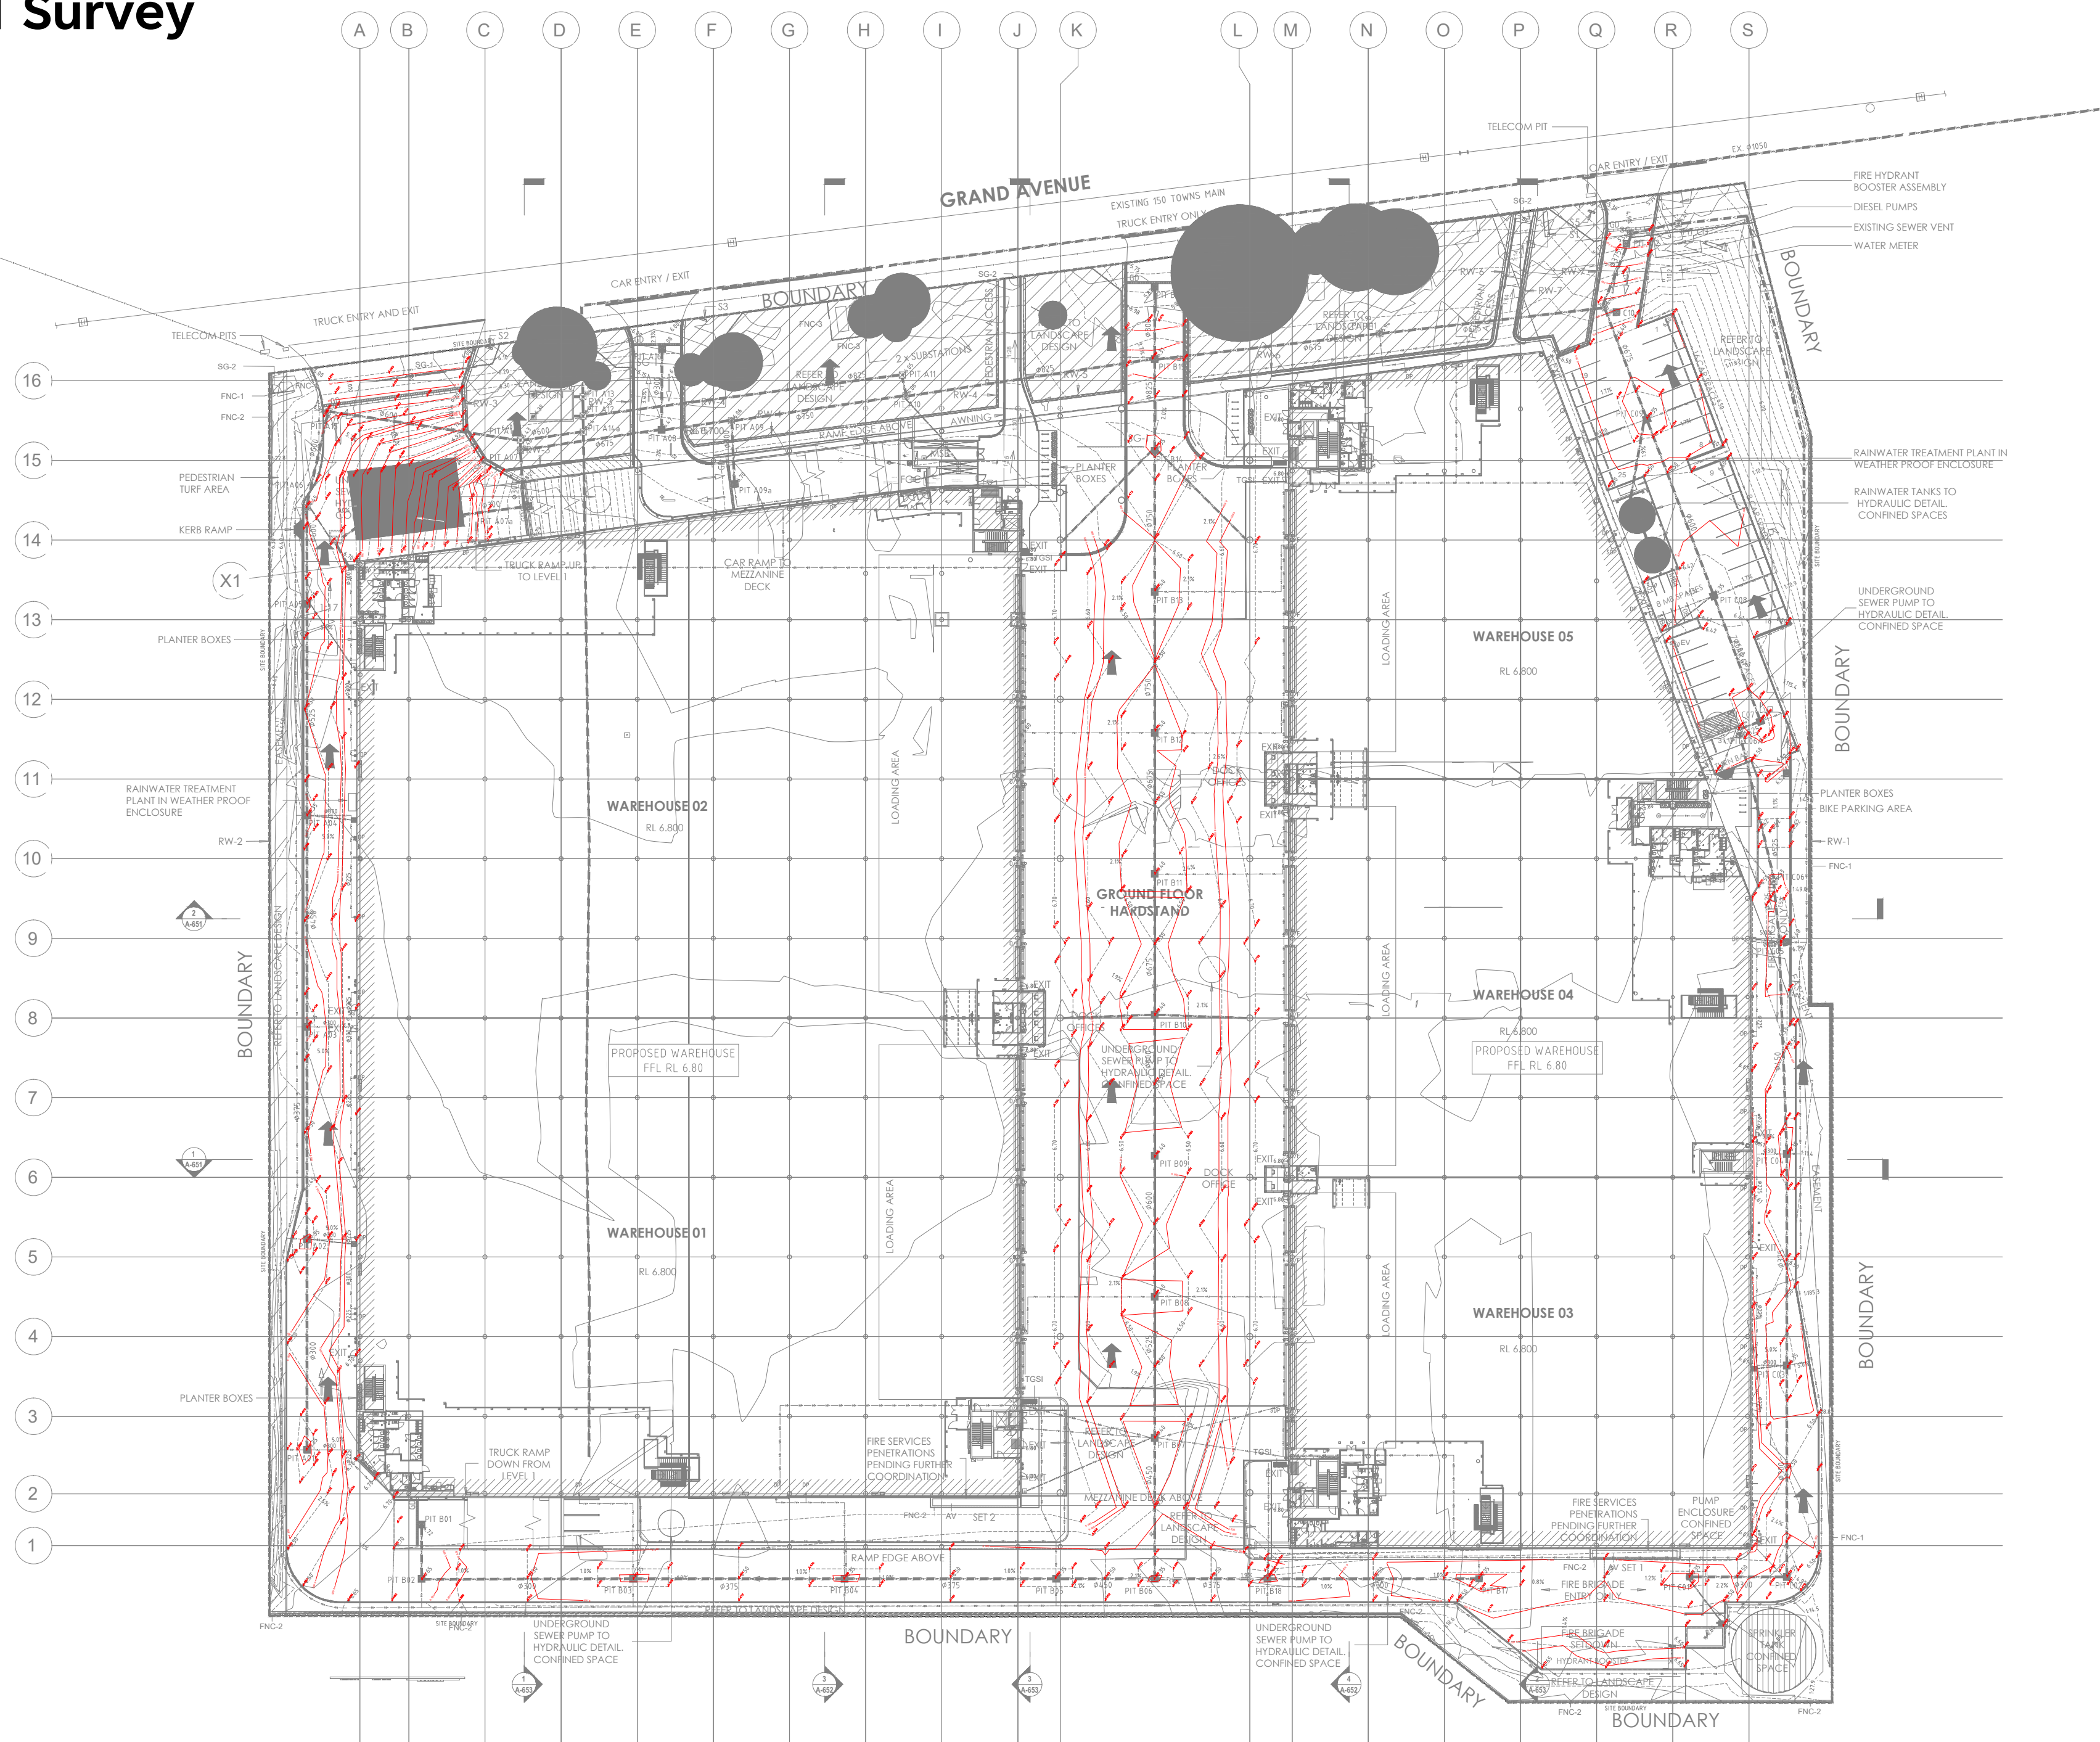
# Final Hardstand Survey

GROUND FLOOR - REDLINE  
6 GRAND AVENUE, ROSEHILL  
REF 241001  
DATE 29.07.2026
