339-349 Horsley Road
Milperra SSD-45998963

Construction Environmental Management Plan

Acid Sulfate Soil Management Plan

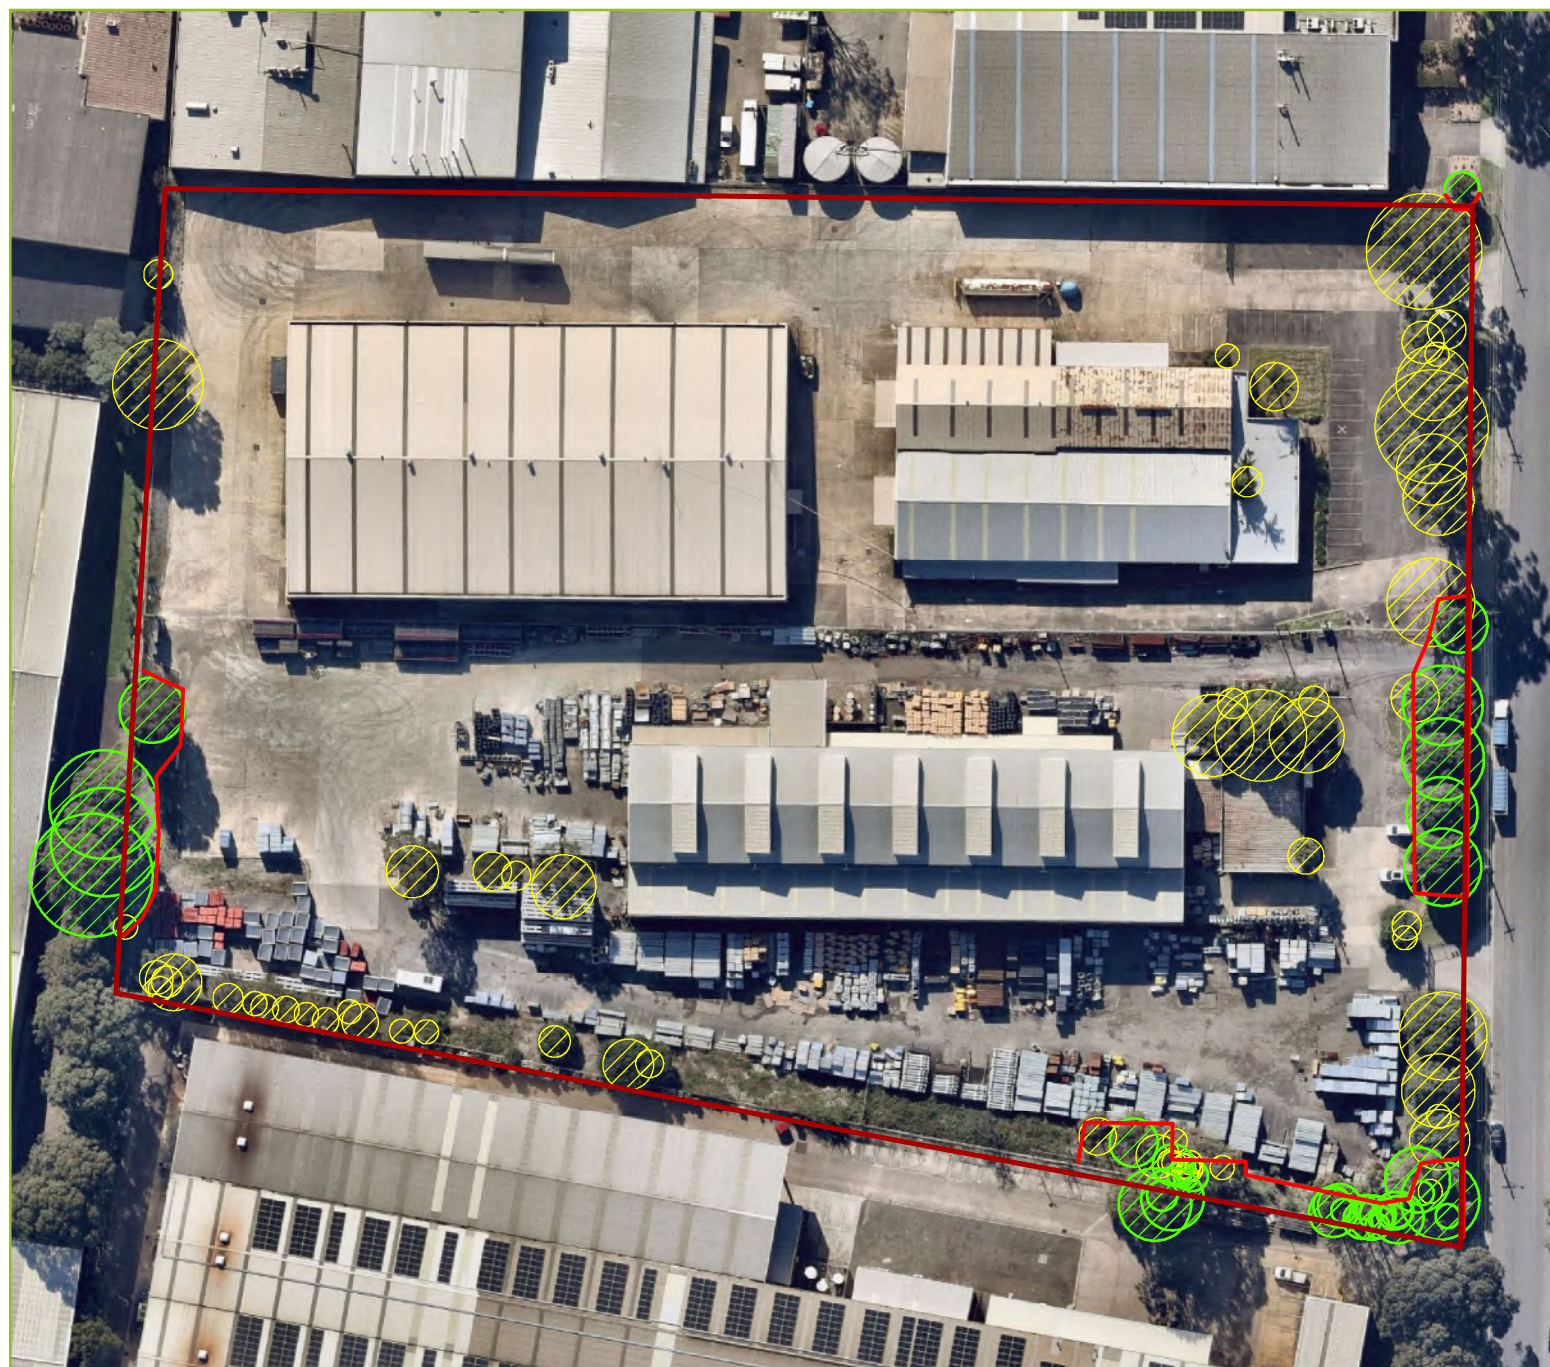
Figure 2-1.
Vegetation clearing

This VMP addresses the approved removal of approximately 1,617 m² (0.16 ha) of planted native vegetation, which comprises the following:

- 467 m² of planted local native species, and
- 1,150 m² of planted non-local species.

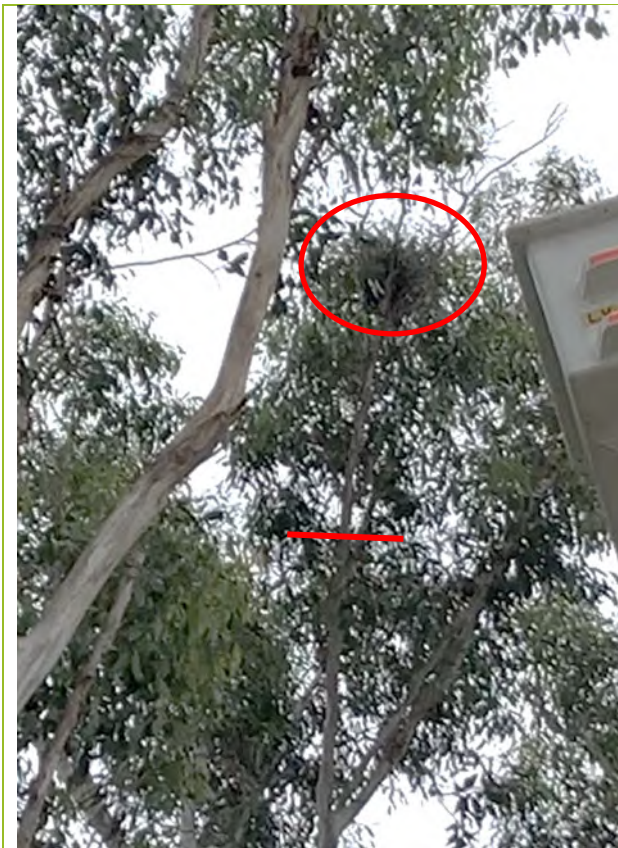
Photo plate 1: location of nest and location of supporting limb where cut

- Removal of the main structural limb supporting an occupied nest and lowered to the ground inside bucket (see photo plates 1 and 2).
- Nests will be relocated and securely fastened to a tree being retained on the Site;

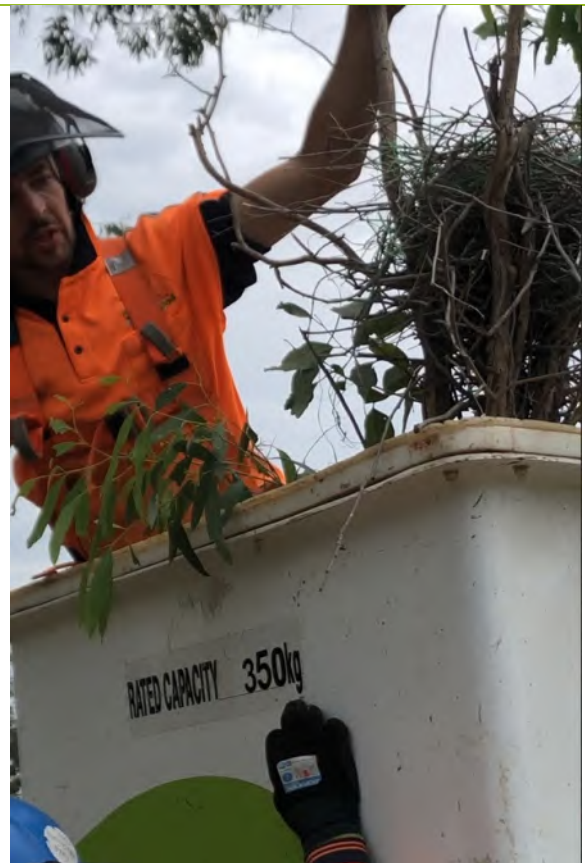
Photo plate 2: nest safely removed and in bucket for relocation

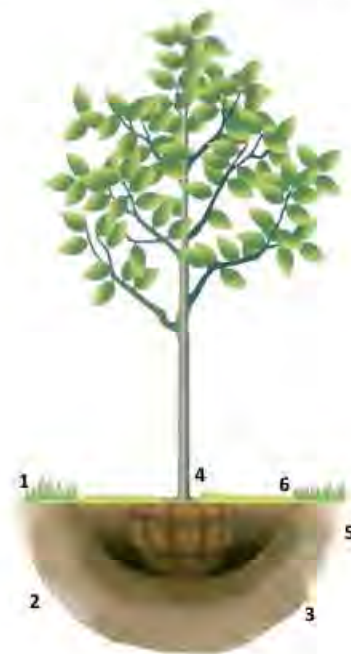
Figure 5: Recommended tree planting process. (Arbor Day Foundation, 2020)

- 1. Dial Before You Dig**
Several days before planting, call the Dial Before You Dig (DBYG) hotline on 1100 or apply via their website to have any underground services identified.
- 2. Handle with Care**
Always lift tree by the root ball. Keep roots moist until planting.
- 3. Digging a Proper Hole**
Dig 2 to 5 times wider than the diameter of the root ball with sloping sides to allow for proper root growth.
- 4. Planting Depth**
The trunk flare should sit slightly above ground level and the top most roots should be buried 25 to 55 mm.
- 5. Filling the Hole**
Backfill with native soil unless it's all clay. Tamp in soil gently to fill large air spaces.
- 6. Mulch**
Allow 25 to 50 mm clearance between the trunk and the mulch. Mulch should be 75 to 100 mm deep.

The trees should be planted and mulched with suitably composted, natural, hardwood mulch as per Figure 5.

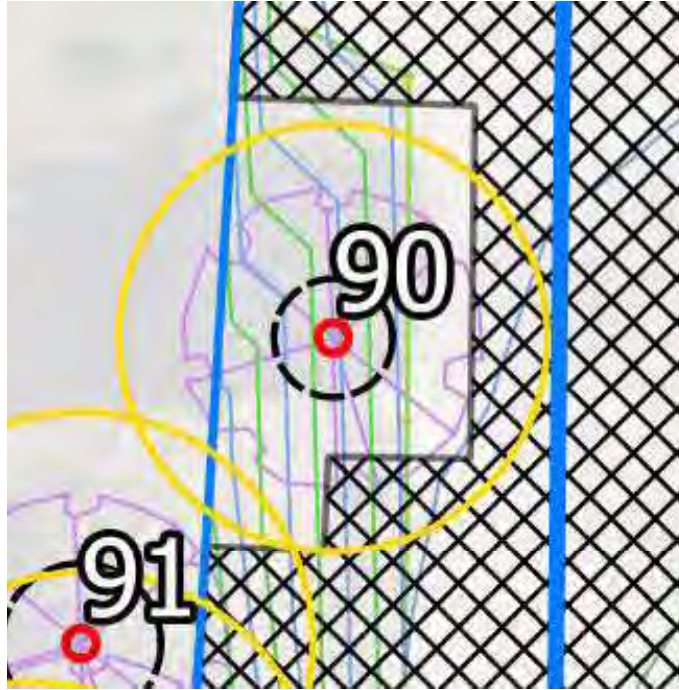
Figure 6: Non-hatched exclusion area required to retain tree 90. Fill using topsoil complying with section 6.8 may be possible within the TPZ subject to project arborist input. If additional fill is required, cellular confinement systems or a dry-well should be investigated to achieve these increased levels.

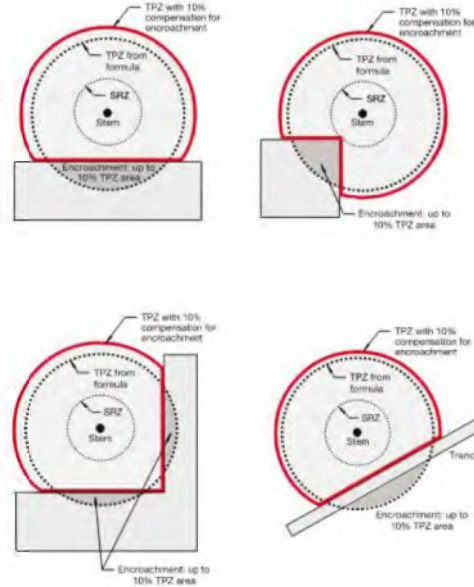
PERMISSIBLE TPZ ENCROACHMENTS

NOTE: Less than 10% TPZ area and outside SRZ. Any loss of TPZ compensated for elsewhere.

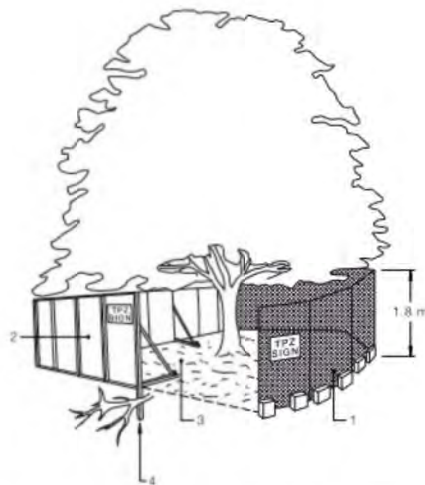
TPZ FENCING DETAIL - ABOVE

- LEGEND:**
- 1 Chain wire mesh panels with shade cloth (if required) attached, held in place with concrete feet.
 - 2 Alternative plywood or wooden paling fence panels. This fencing material also prevents building materials or soil entering the TPZ.
 - 3 Mulch installation across surface of TPZ (at the discretion of the project arborist). No excavation, construction activity, grade changes, surface treatment or storage of materials of any kind is permitted within the TPZ.
 - 4 Bracing is permissible within the TPZ. Installation of supports should avoid damaging roots.

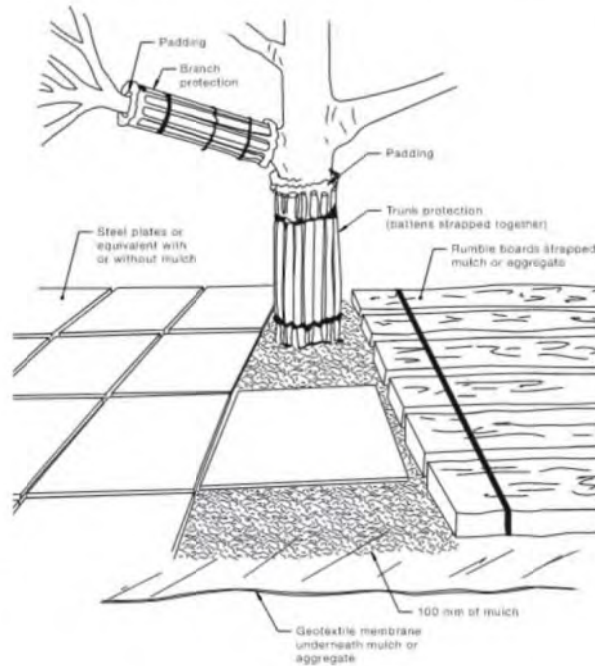
TRUNK BRANCH AND GROUND PROTECTION DETAIL

GROUND PROTECTION IS TO BE INSTALLED AS SHOWN IN THE TPMP PLAN. THE PURPOSE OF GROUND PROTECTION IS TO PREVENT ROOT DAMAGE AND SOIL COMPACTION. MEASURES MAY INCLUDE A PERMEABLE MEMBRANE SUCH AS GEOTEXTILE FABRIC BENEATH A 100MM THICK LAYER OF MULCH OR CRUSHED ROCK BELOW RUMBLE BOARDS, OR STEEL PLATES OR TRACK MATS.

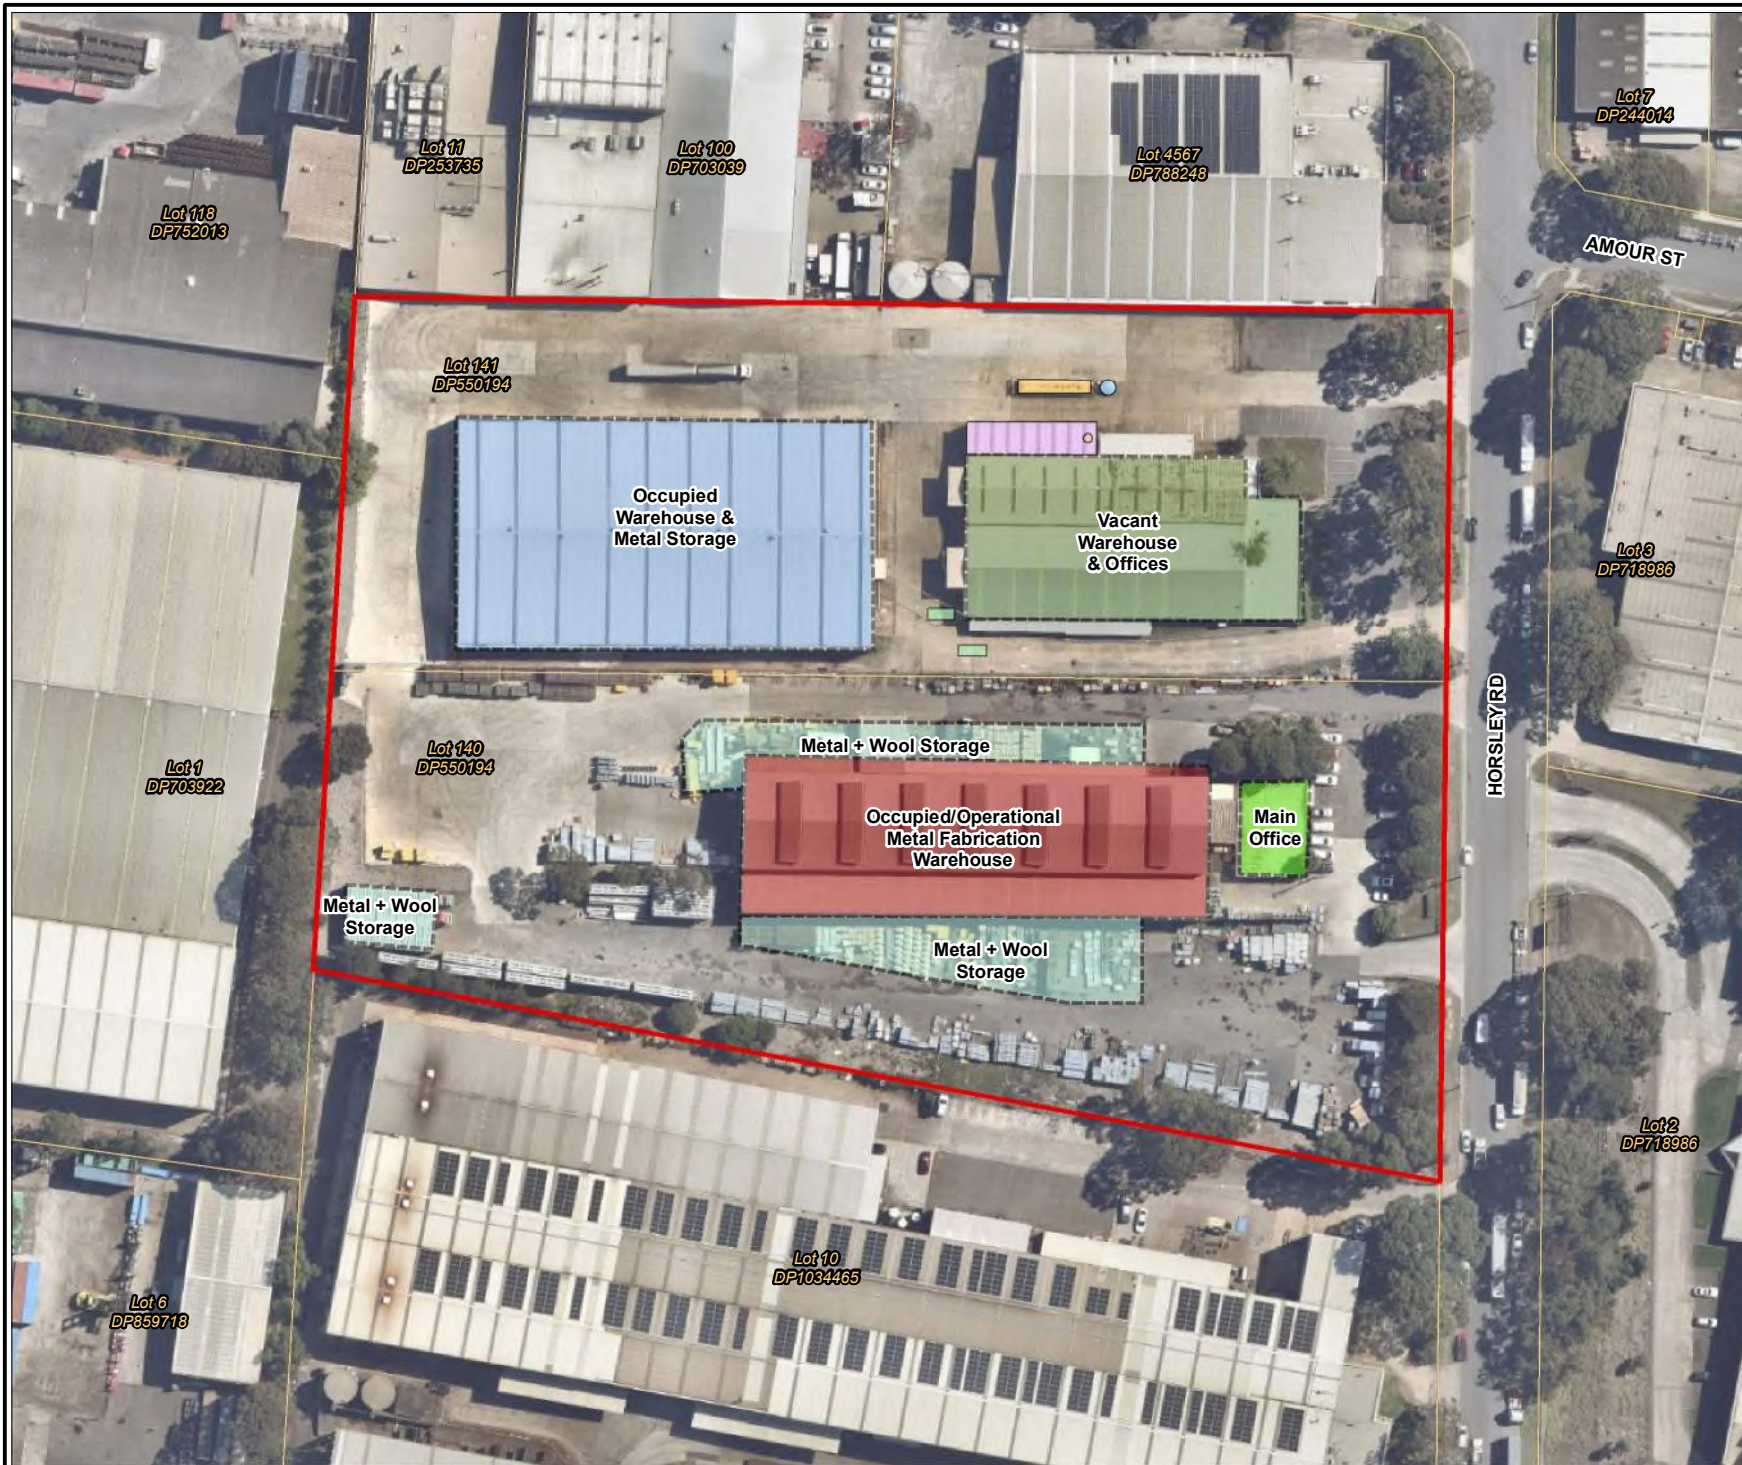
FIGURE 2

- ▬ Approximate Site Boundary
- ▬ NSW Cadastre (DFS1, 2022)
- Site Features**
- ▬ AdBlue AST
- ▬ Diesel AST
- ▬ Truckwash
- ▬ UST
- ▬ Waste Water Collection System
- ▬ Main Office
- ▬ Metal + Wool Storage
- ▬ Vacant Warehouse & Offices
- ▬ Occupied Warehouse & Metal Storage
- ▬ Occupied/Operational Metal Fabrication Warehouse

SITE LAYOUT & FEATURES

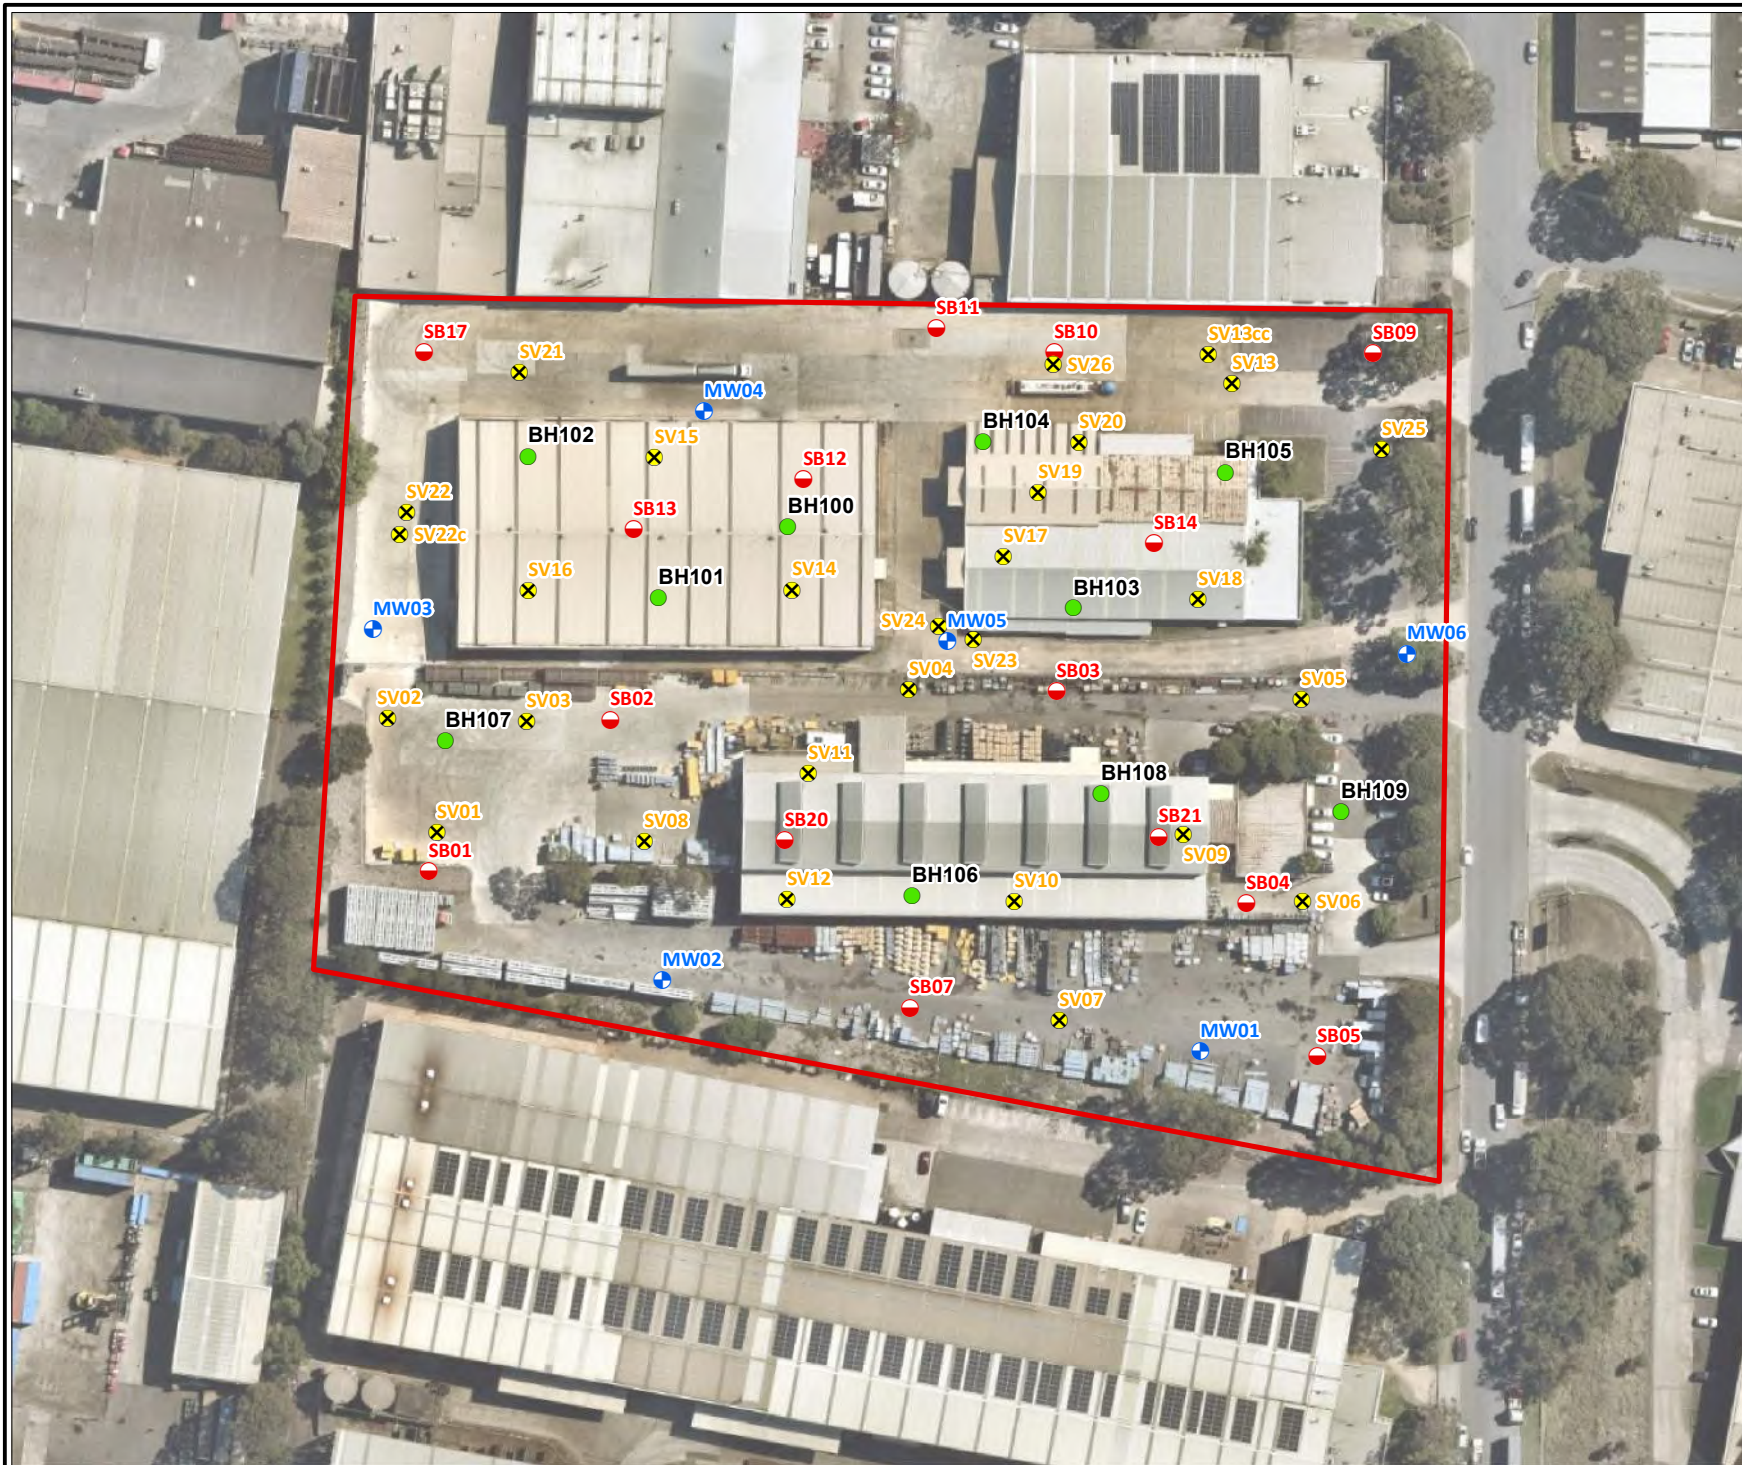
- Approximate Site Boundary
- Sample Locations
 - Borehole (JBS&G 2022a)
 - Monitoring Well (JBS&G 2022a)
 - Soil Vapour (JBS&G 2022a)
 - Borehole (JBS&G 2022b)

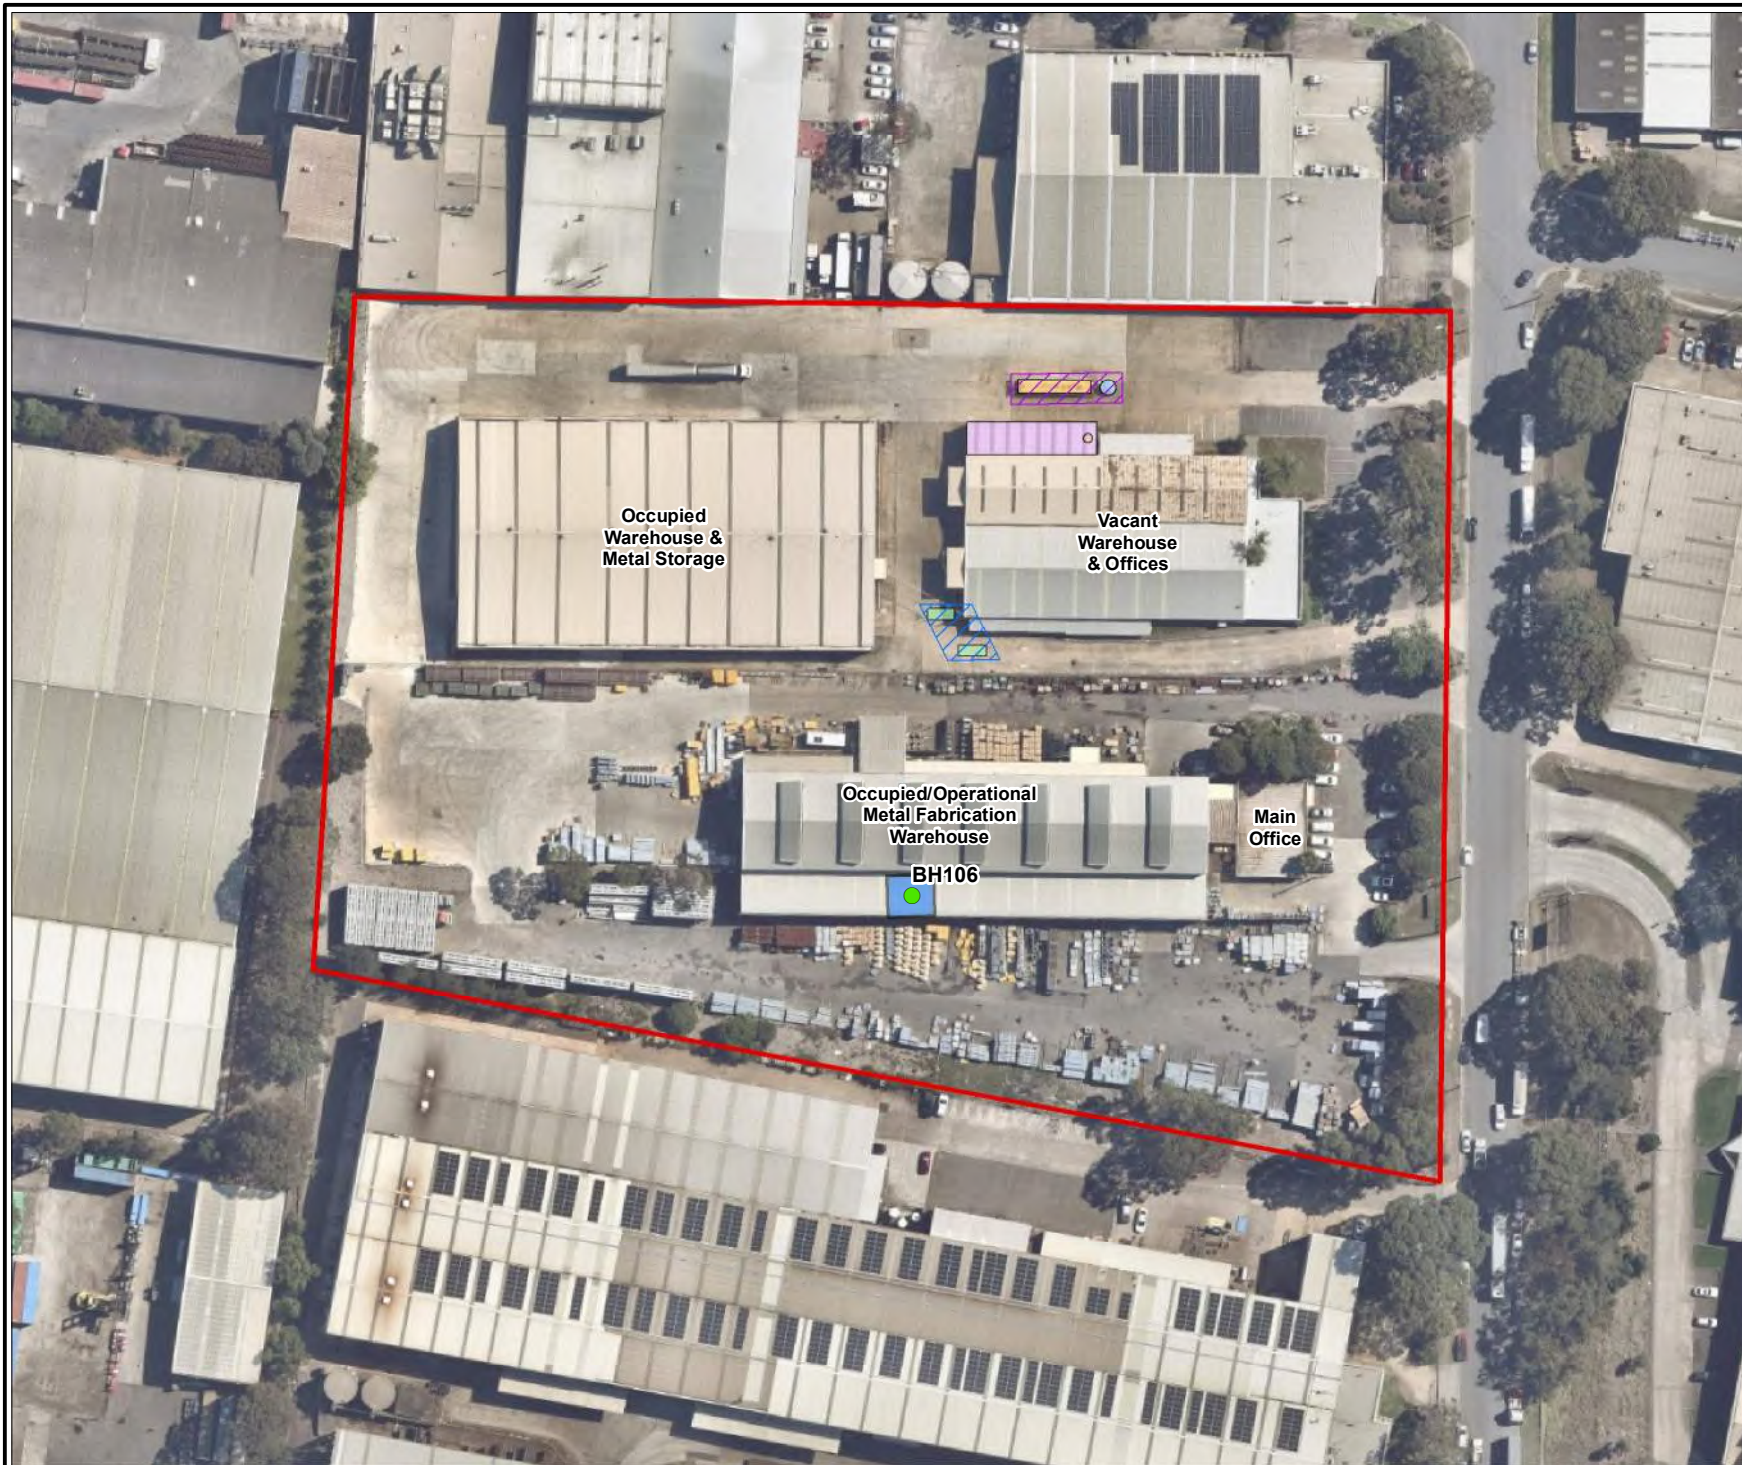
FIGURE 4

**SOIL EXCEEDANCES
(JBS&G 2022a and 2022b)**

Investigation works identified the presence of the following AECs and COPC warranting remediation/management, as presented in **Table 4.1** and shown on **Figure 4**. No evidence of unacceptable contamination conditions was identified within the other potential AECs.

Bonded asbestos has been identified in one area underlying the site. The location of the identified ACM is shown on **Figure 4**.

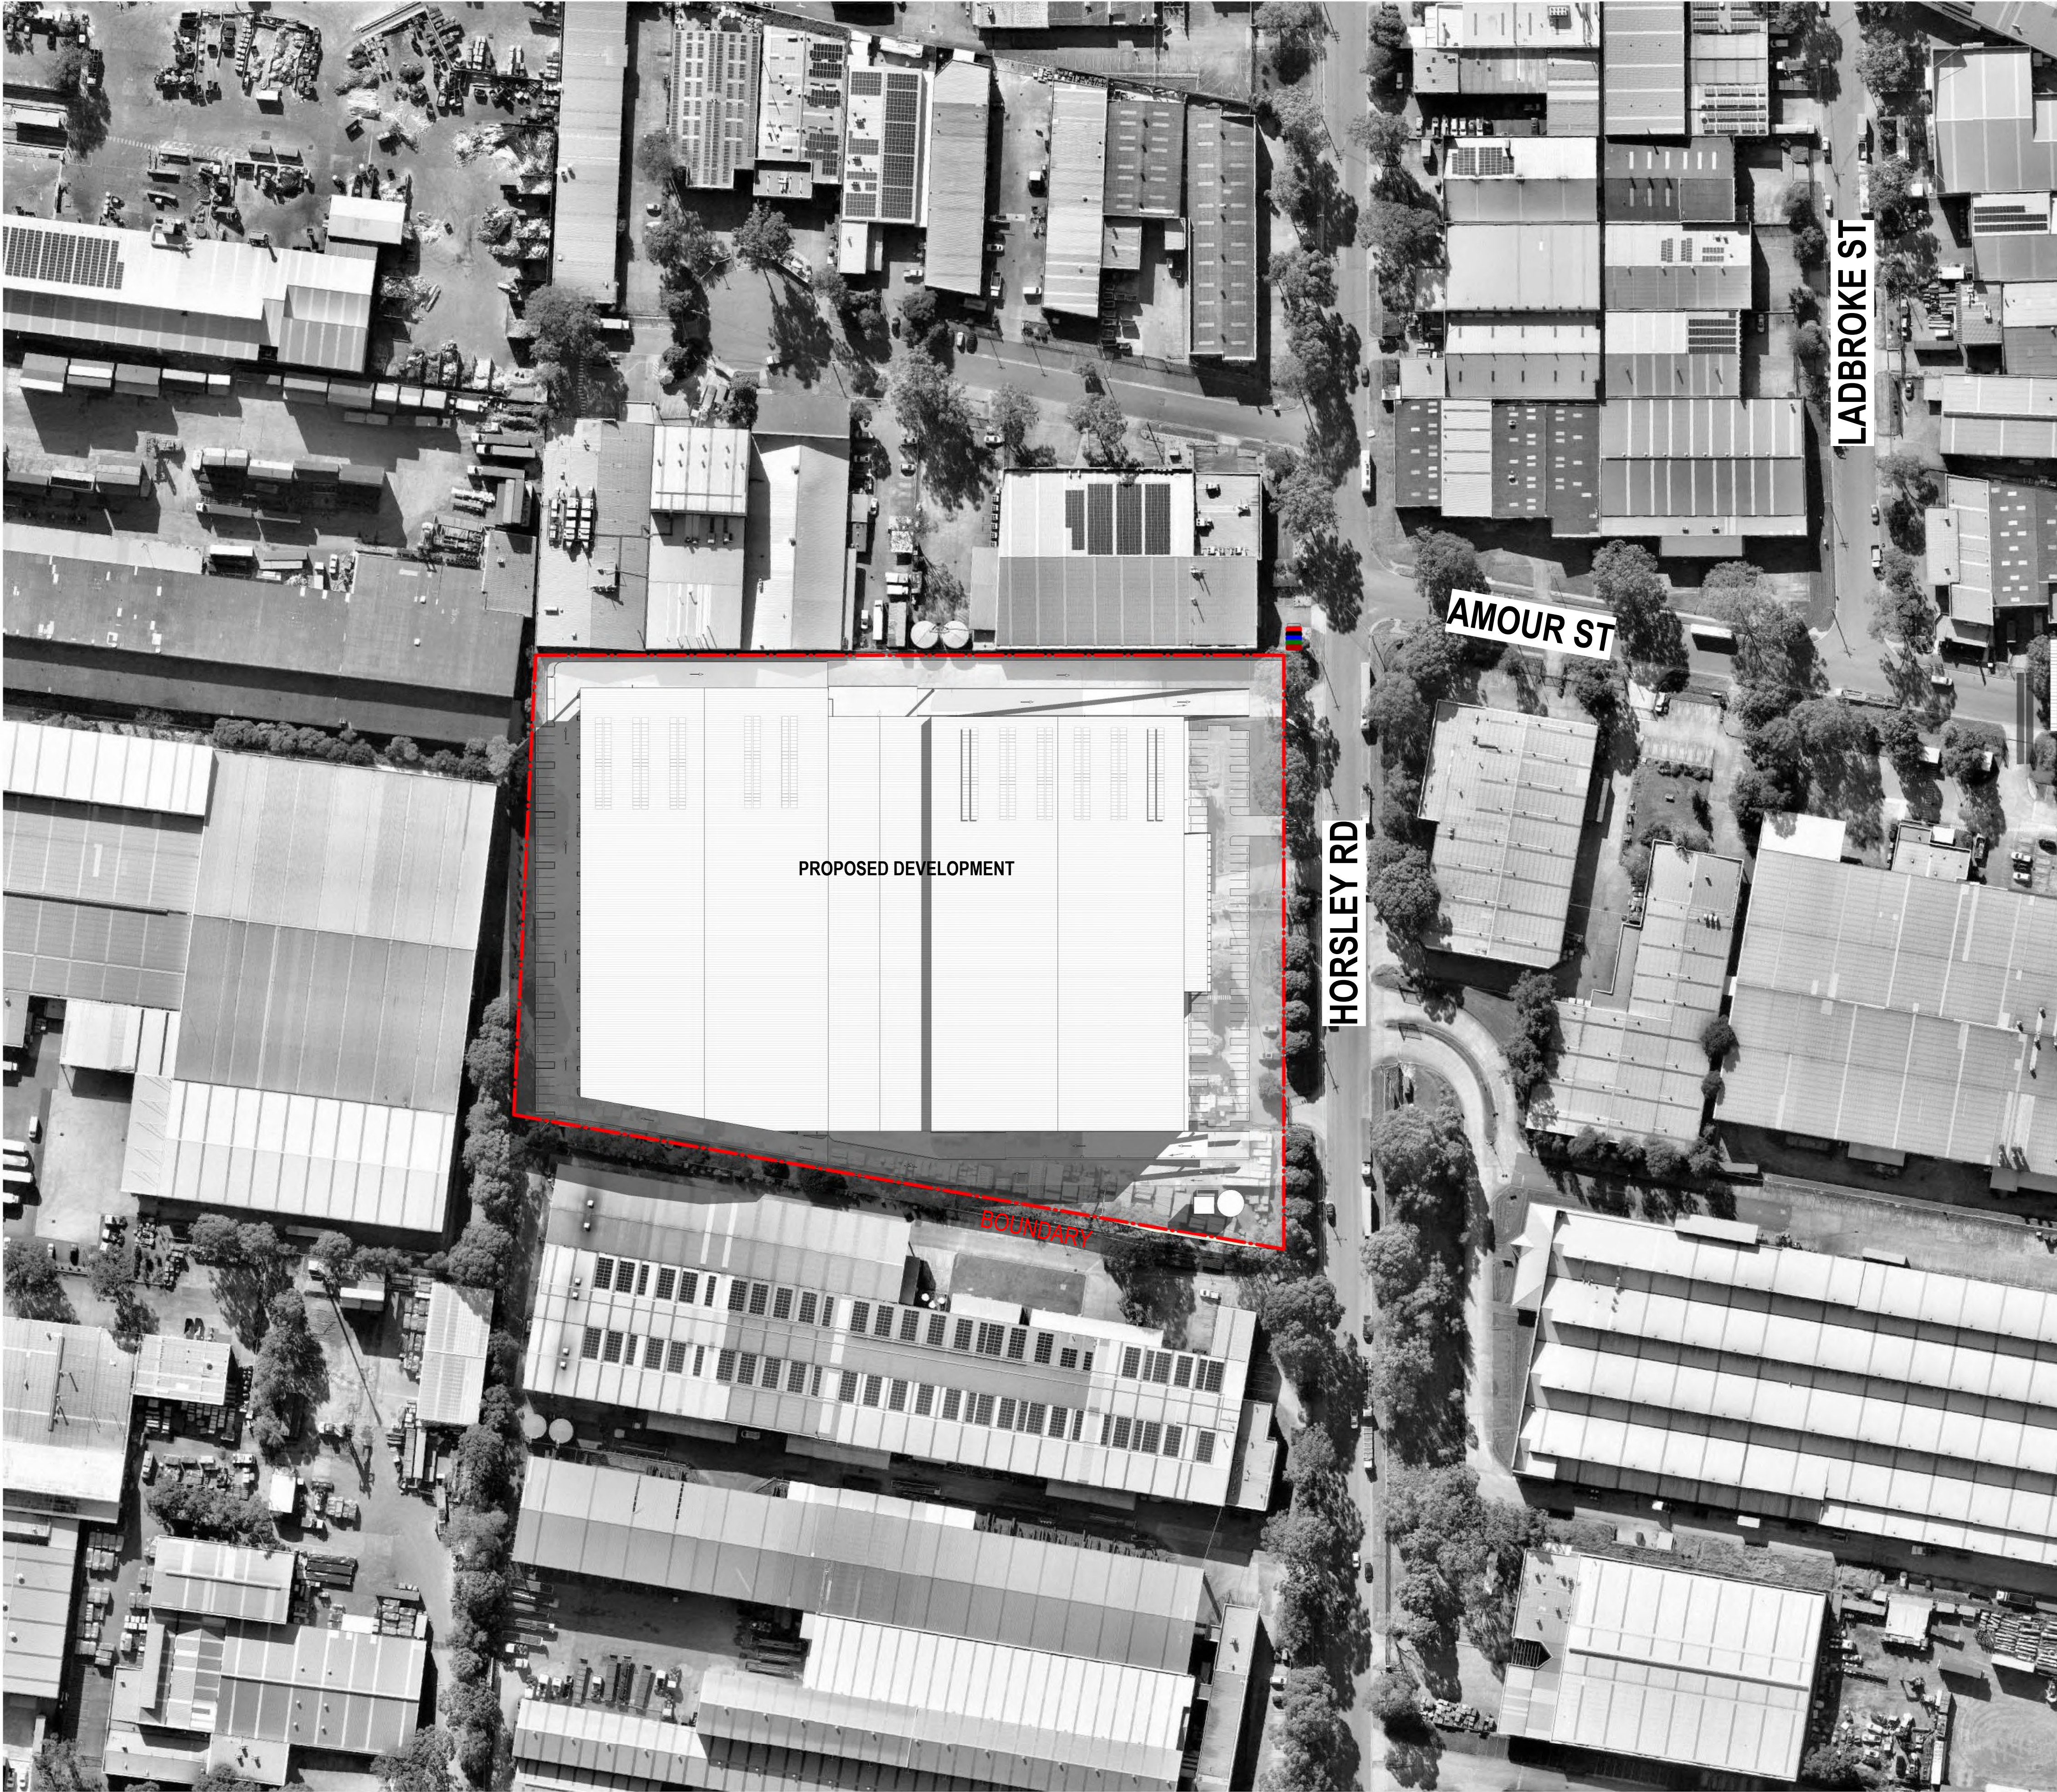
DEVELOPMENT SUMMARY		
GLA CALCULATIONS:		
DEVELOPABLE SITE AREA		33,772 m²
OFFICE <varies>		3,204 m²
WAREHOUSE <varies>		34,109 m²
TOTAL GLA:		37,313 m²
PROPOSED FSR		1.1:1
LANDSCAPE AREA	13.9%	4,685 m²
CAR SPACES REQUIRED		146
CAR SPACES PROVIDED		150
MOTORCYCLES PARKING		XX
BICYCLES PARKING		20

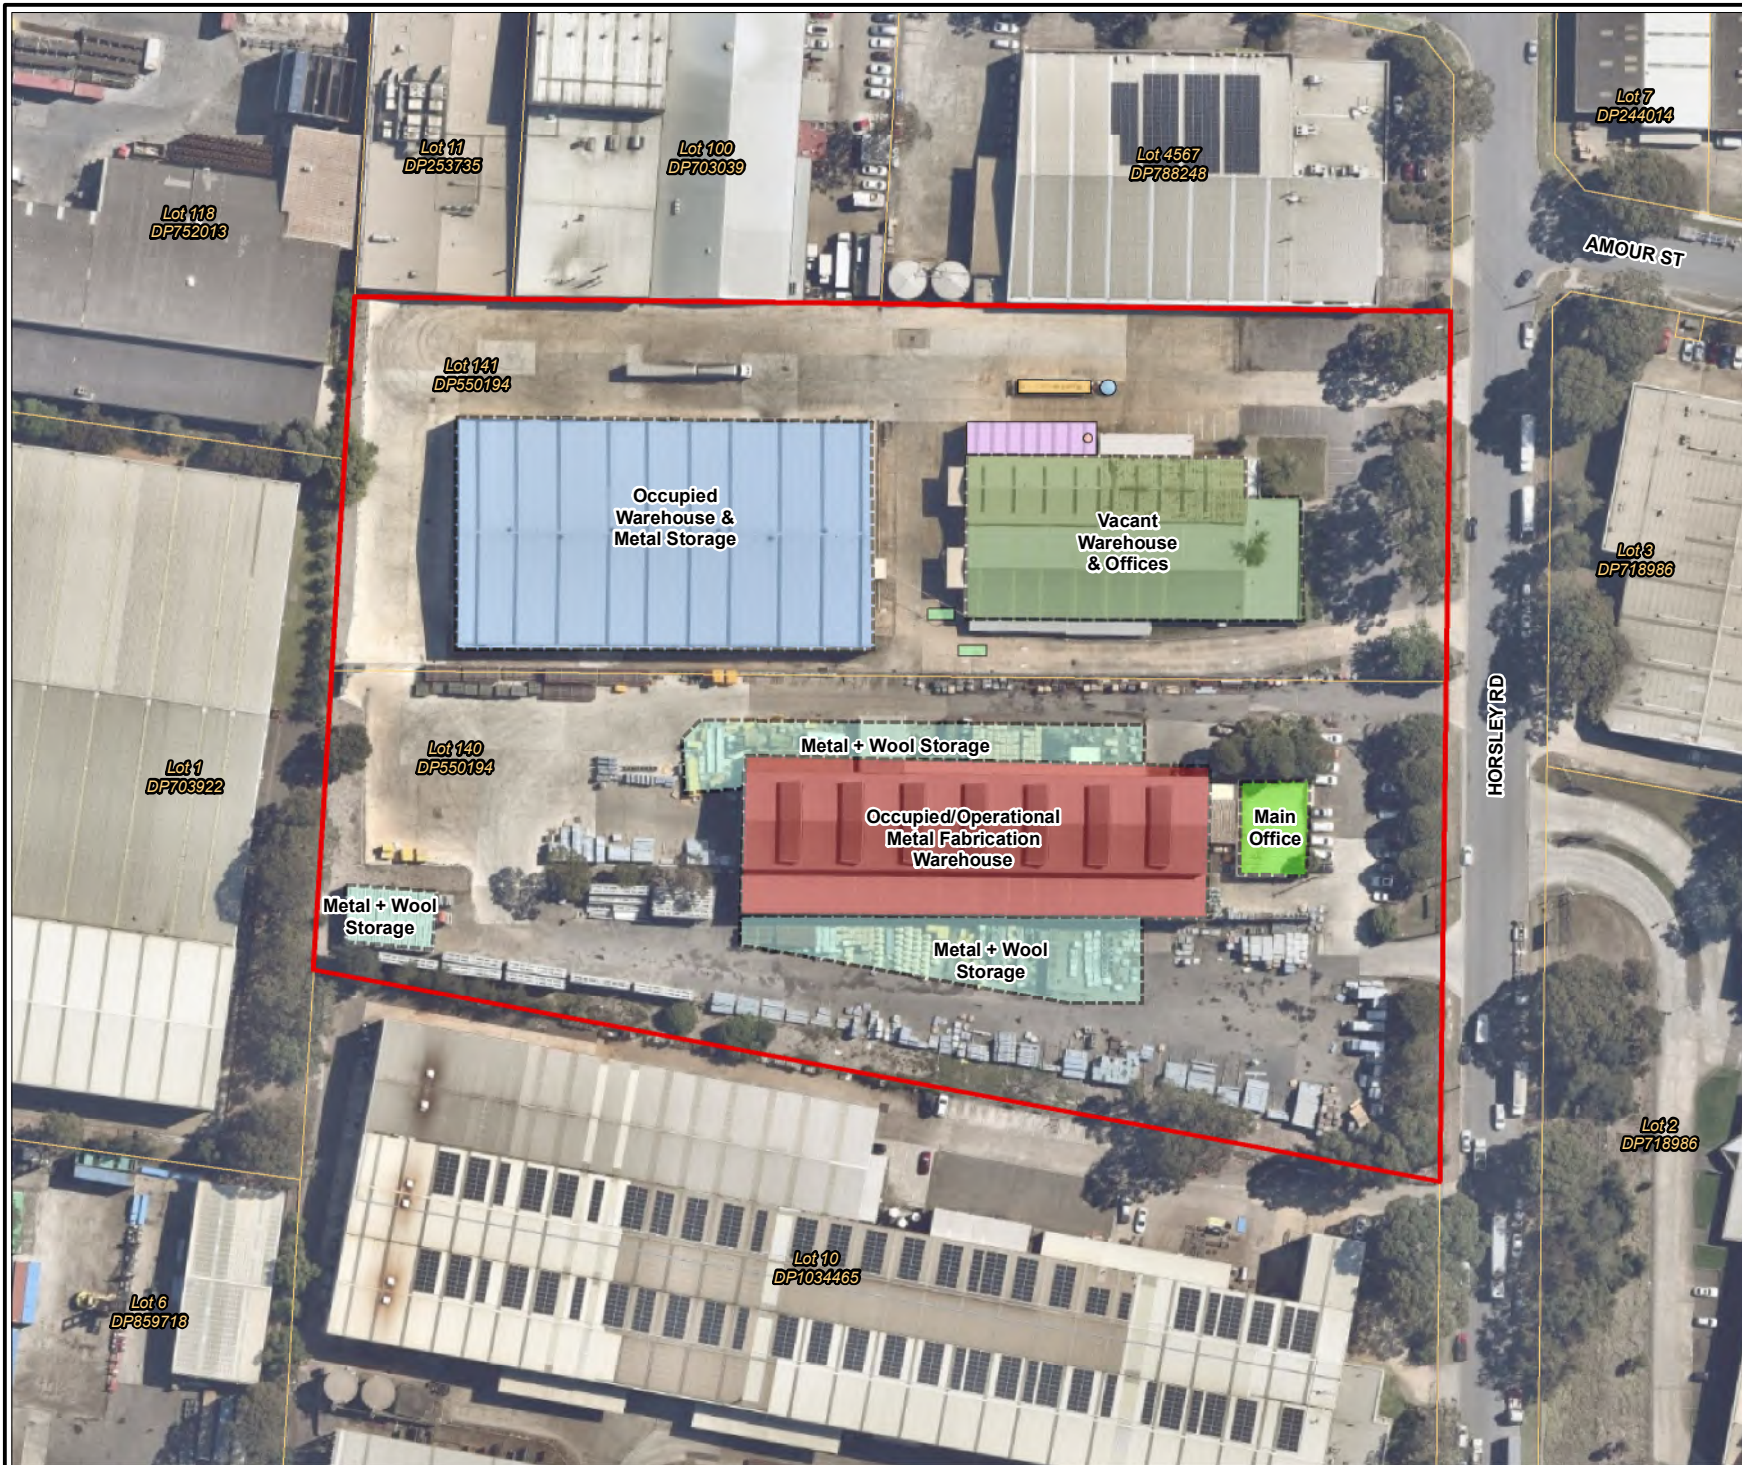
FIGURE 2

- Approximate Site Boundary
- NSW Cadastre (DFS1, 2022)
- Site Features**
- AdBlue AST
- Diesel AST
- Truckwash
- UST
- Waste Water Collection System
- Main Office
- Metal + Wool Storage
- Vacant Warehouse & Offices
- Occupied Warehouse & Metal Storage
- Occupied/Operational Metal Fabrication Warehouse

SITE LAYOUT & FEATURES

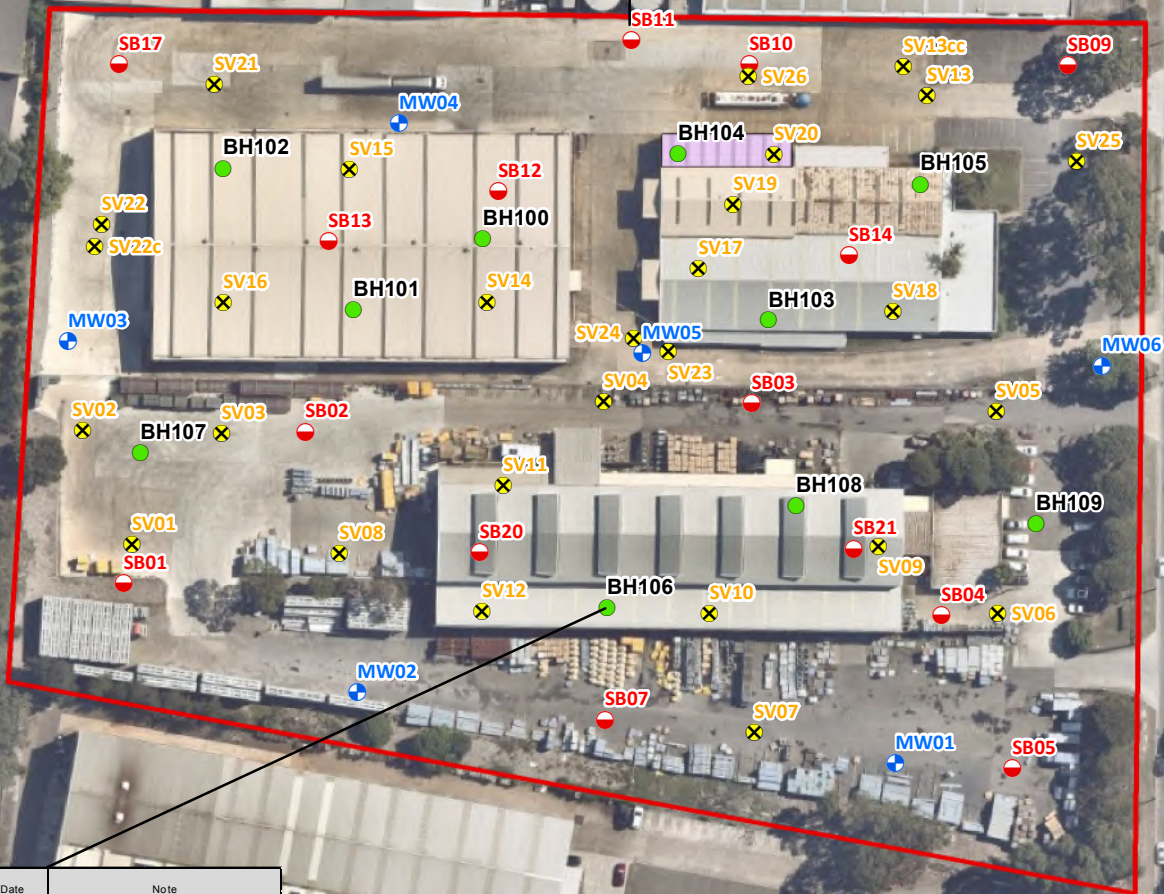
SB 11	Depth (m)	Date	Concentration (mg/kg)	Criteria
Analyte				
F2 (C-D-C 15 less Naphthalene)	0.25-0.3	15/03/2022	260	NEPC (2013) ESLs for Comm/Ind, Coarse Soil

BH 106	Depth (m)	Date	Note
Analyte			
Asbestos	0.4-0.5	7/07/2022	Asbestos Fragment "FRAG20220708_01"
