339-349 Horsley Road
Milperra SSD-45998963

Construction Environmental Management Plan

Acid Sulfate Soil Management Plan

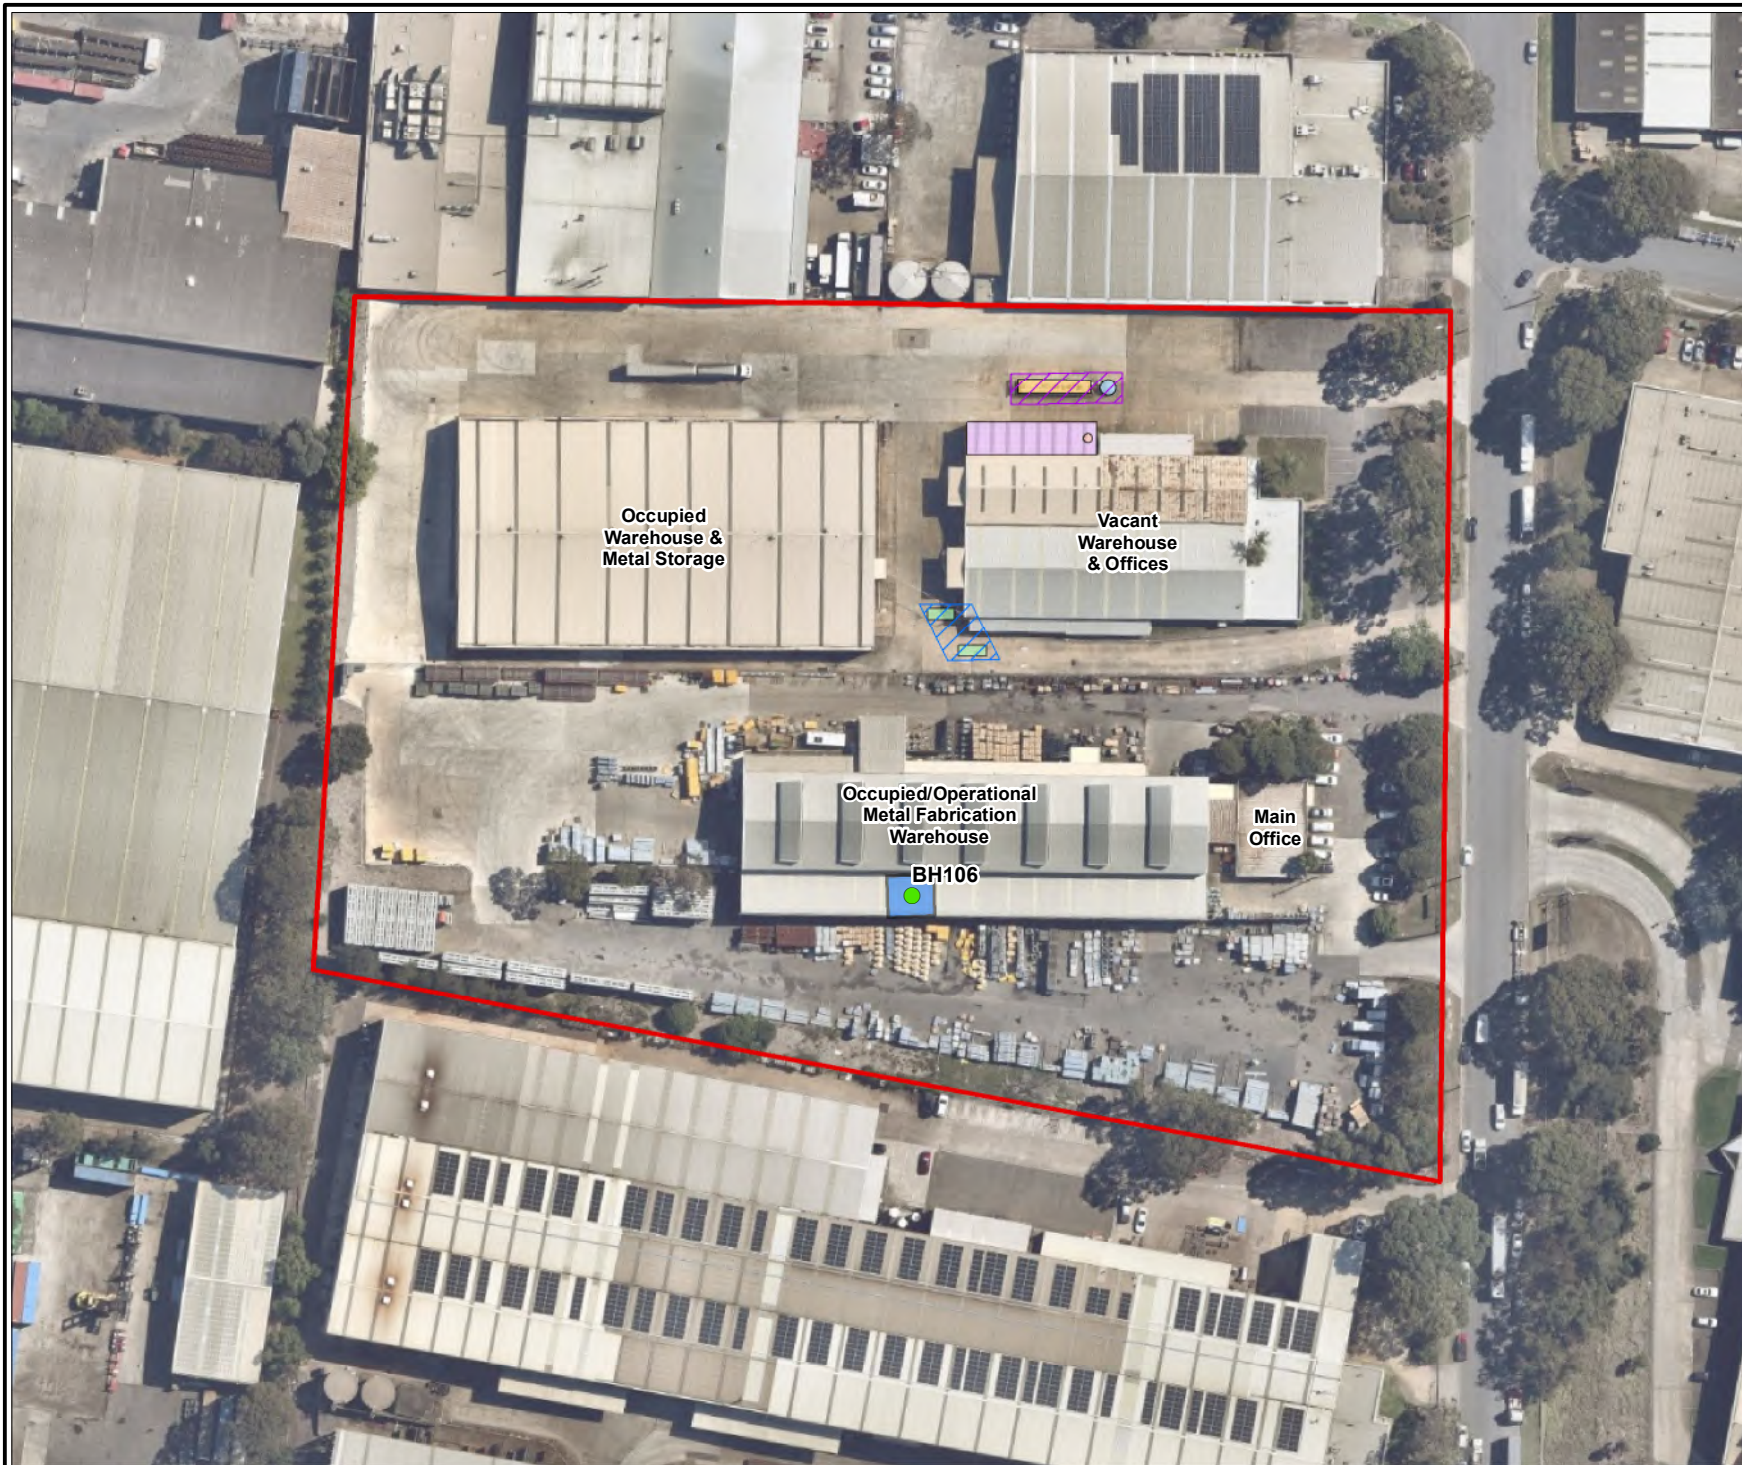
FIGURE 4

**SOIL EXCEEDANCES
(JBS&G 2022a and 2022b)**
